## *Underdrain Inspection on April 4, 2020 – Clay and Russ*

**Link to: [Several Maps for the underdrains, all located on SSSF private Homeowner property.](#)**

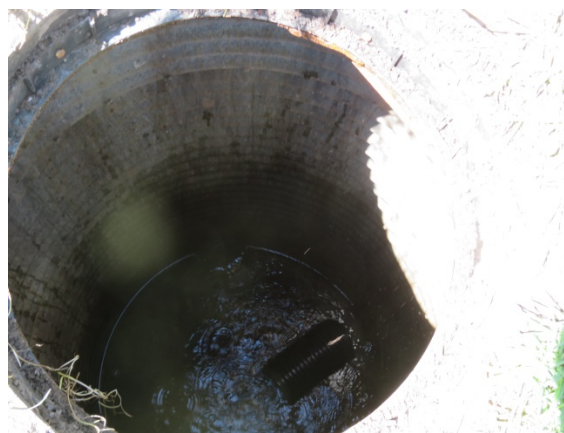
Lot 25 **MH 11A** shows less than 50% flow, water height does not cover the 6" diameter plastic hoses.

This manhole **11A** should be taken off the inspection and clean-out list. **Very little activity.** The black corrugated tube is loose at the bottom of the conduit, broken off by Pro-Pipe during inspection.

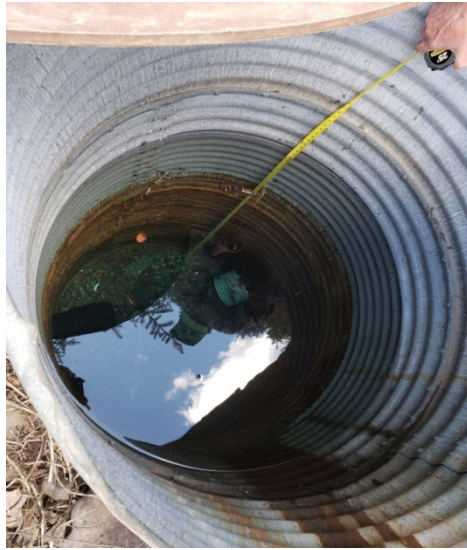
*Lot 54 **MH 10A** water level is about 82". By May 4th it was down to 20" level. Today due to a high inflow source, possibly an artesian spring, between Lot 25 MH 11A and between Lots 26 and 27. There existed a creek between those two lots that was filled in sometime between 1987 and 1994 according to aerial maps from those years, and several neighbors' recall.*

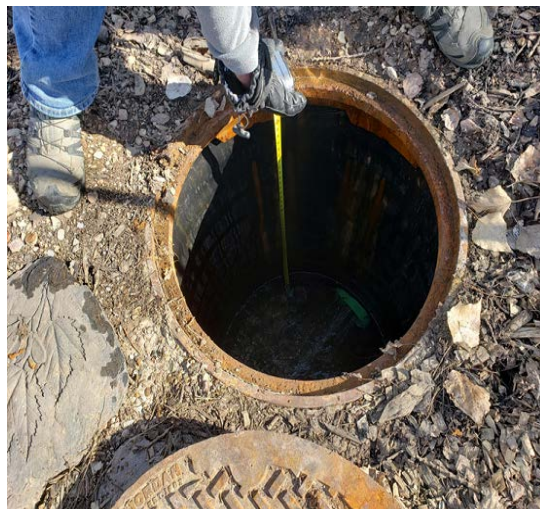
***MH 8A** located between Lots 67 & 68, near the curb, flows north (to lower elevation) from MH10A to 8A; also from MH 7A on Lot 87, flows east to MH 6A; MH9A between Lots 70 and 71 joins MH 7A and 6A to then flow together into the exit drain pipe into Willow Creek.*

*Our inspection of this exit drain shows normal flow, about 1" to 2" above pipes, approximately 10" of water. Roots are visible extending out of the 8A MH perforated pipe at the bottom of the steel conduit.*

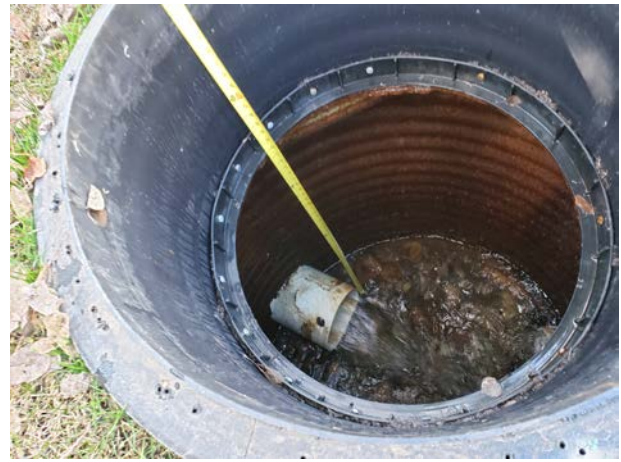
water through a PVC pipe into Willow Creek, no reduction or increase in and out of this drain this year.

**(Right) MH 6A** on Lot 87 *discharges collected*

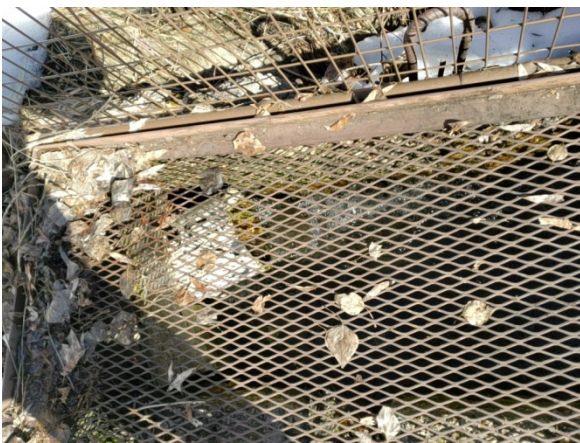
Leaving MH 6A, water outflow through PVC drainpipe under East Meadows Dr., then between Lots 105 and 106, moves water to Willow Creek.
