SILVER SPRINGS SINGLE FAMILY SUBDIVISION - SEGMENT A 17 MAN HOLES

Report Compiled by Clay and Lucy Archer, contributions by Bradley Hornsby 5/26/2020

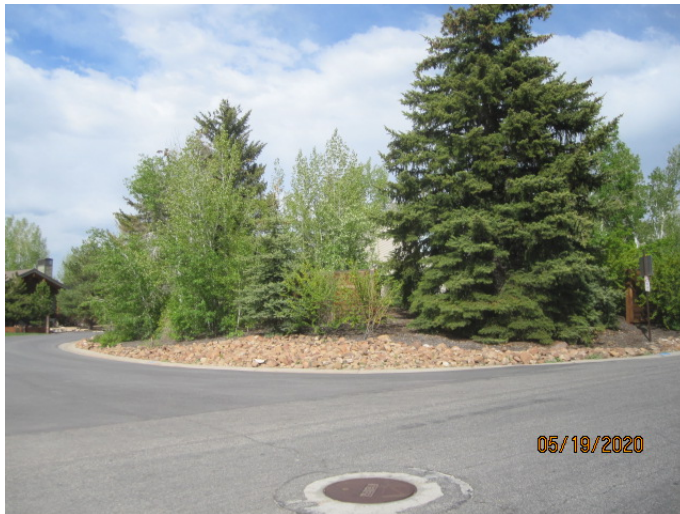
Mh 1A Lot 16 at corner of Silver Springs Drive and Meadows Connection. Robertshaw. Alliance Engineering Map Report: "Found steel lid in landscape rocks at 13" depth "at center of curve of the two streets. 7.1 feet behind gutter; 44 feet from sewer manhole; 53.7 feet from street sign." Direct measurement with surveyor chain. No inflow, unless via perforated tubes

6' to 10' underground. Planned out flow is diagonally under and across Meadows Connection to Lot 17 Manhole 13A.

Owner has covered curve easement with red rocks. The Alliance Engineering Map shows a gap between the location of Mh 1A and the beginning of the underdrain line to Mh 2A. We don't know whether it is a drafting error or whether the line between 1A and 2A in ground-truth are indeed not joined to each other.

Buried under berm and rocks. **Inactive.**

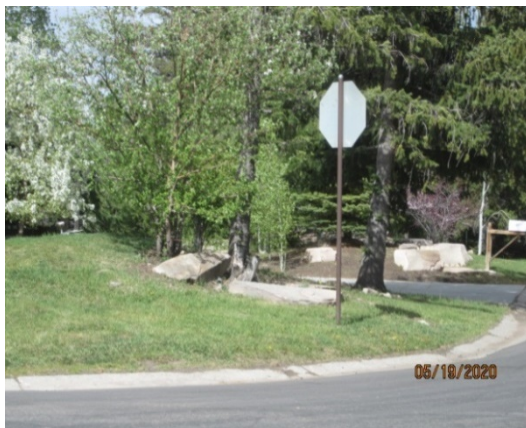
Mh 2A Lot 1 at corner of East Meadows Dr. and Silver Springs Drive. Clark-Oberholtzer-Villano. Alliance Engineering: "Did not find manhole. Strong metal detector signal at excavated depth of 18". 5.4 feet behind gutter. 11.7 feet from Stop sign." Buried under berm. If there is any inflow, it would be via perforated tubes 6' to 10' underground. **Inactive.**

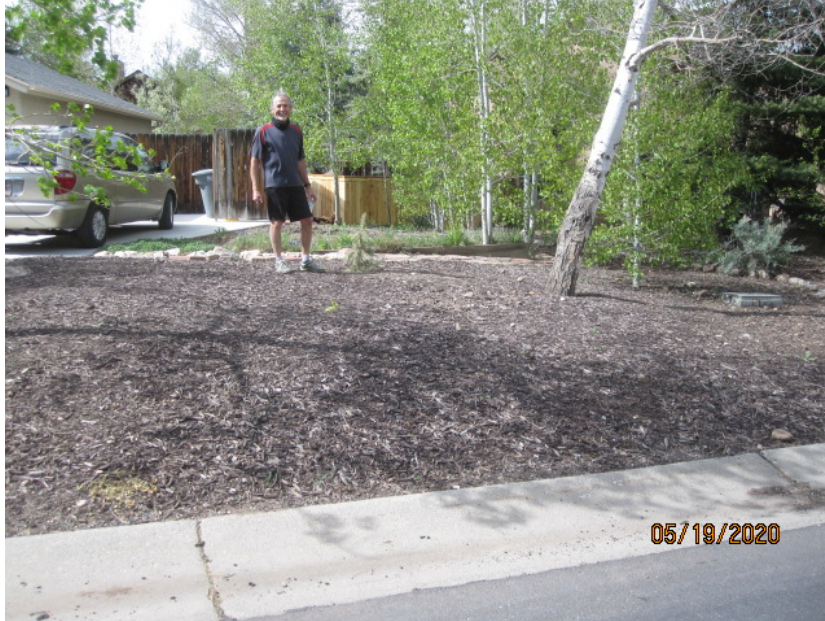
Mh 3A Lot 4 on 4841 East Meadows Drive. Mailbox 25.1 ft. 21.5 ft from sewer manhole. Owner since 1992, Paskoski, told us the mh 3A lid is directly in front of where he is standing 12' behind the gutter, and east of his driveway. The steel lid has a large cable over the top of the lid. He will be adding landscaping in this area again. Buried under this berm. Dry unless there is inflow via perforated tubes 6' to 10' underground. **Inactive.**

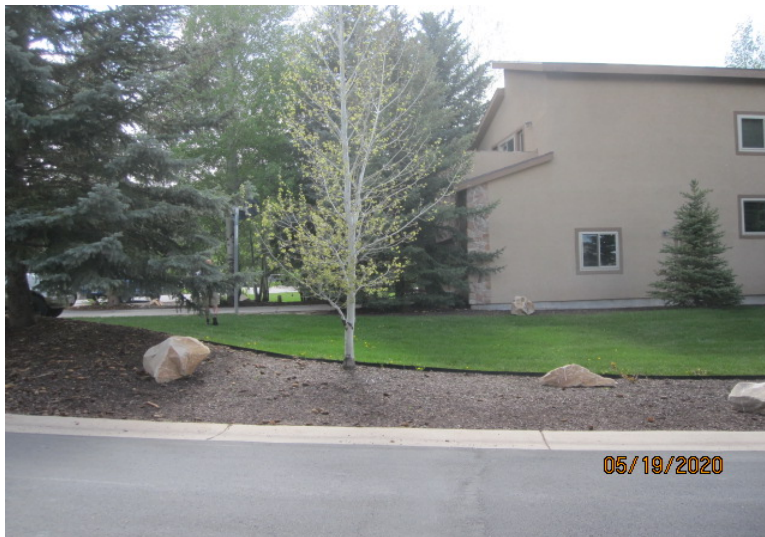
Mh 4A on Lot 26 at the corner of Meadows Connection and East Meadows Drive. Kahn-Brady. Alliance Engineering in 2014 wrote: "Steel lid exposed, 5.8 ft behind gutter. 2014, the lid is buried in landscaping at grade. 14 ft. from street sign." Owner since 1992 has since changed the landscaping, covering the area with chipped bark. A 'lost creek' existed between Lot 26 and 27, as seen on aerial photographs dated 1987 and to 1992, and remembered by neighbors. When the creek was covered did flow energy convert to subterranean activity directed to adjoining lower elevation properties? Lots 28, 29, 54, 55, 56, 57? Manhole 4A is buried under landscaping along this curb. No inflow, other than via perforated tubes 6' to 10' underground. Dry when compared to the minimal collection next door in manhole 11A on Lot 25. **Inactive.**

Dry when compared to the minimal collection next door in manhole 11A on Lot 25. **Inactive.**

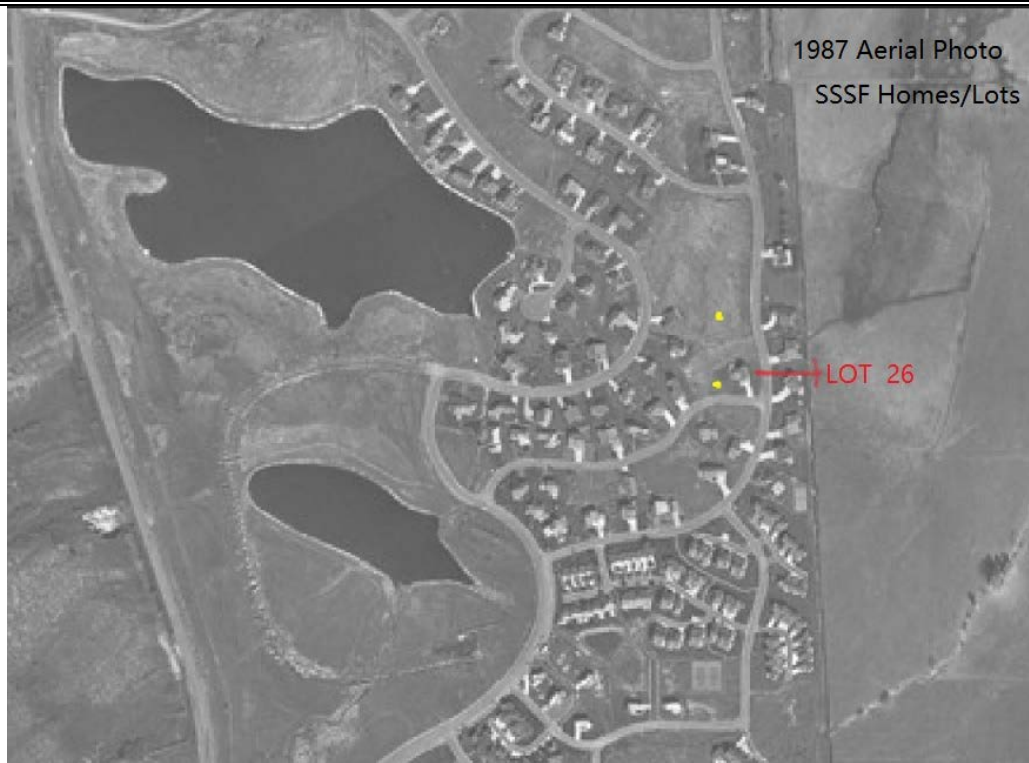
This 1987 Aerial Photograph above shows (between the two yellow dots) a creek existed between Lots 26 and 27. Neighbors remember traversing its small bridge. Just how filling-to-extinction, the small creek on Lot 27, affected subsurface flow is speculation at this point.

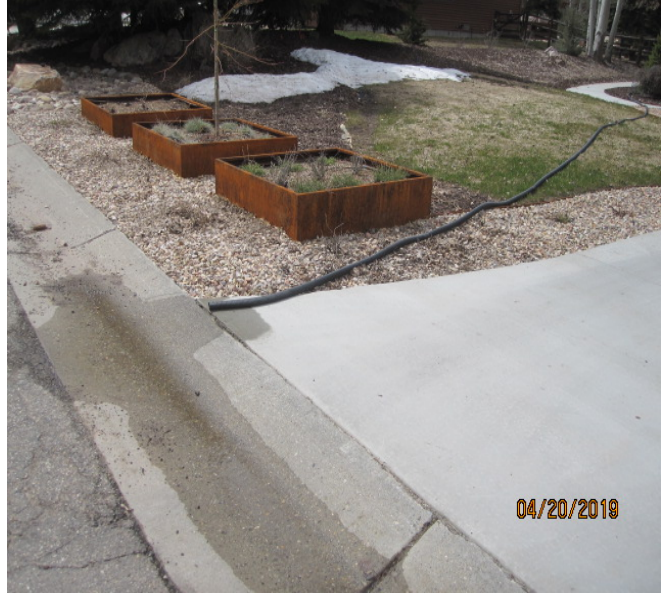
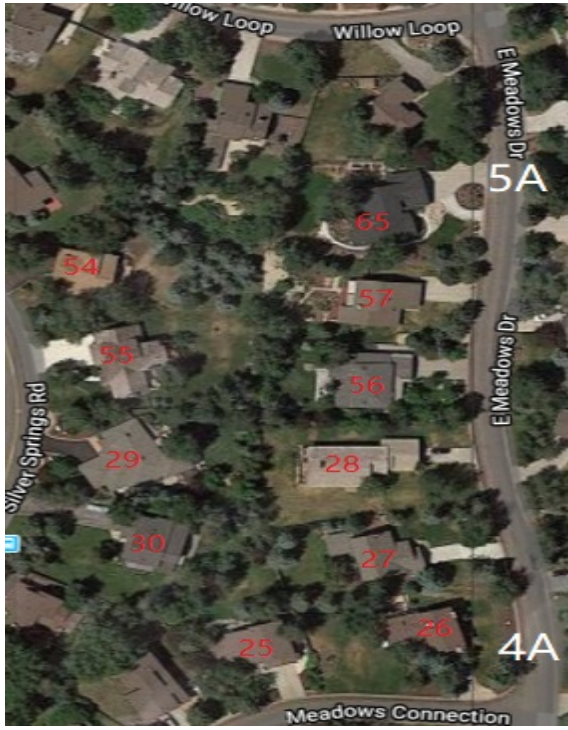
Mh 5A Lot 65 Kotsenburg on East Meadows Drive. Alliance Engineering: “Did not find this manhole.” The underdrain line from mh 4A to mh5A was declared either “not completed” or “collapsed”. A 2007 inspection of this line starting at Mh6A, toward Mh 4A was accessible a mere 6 horizontal feet. A ‘lost creek’ existed between Lot 26 and 27, as seen on aerial photograph above in 1987 to 1992. We are investigating whether filling in the stream by the owner of Lot 27 had an effect on crawlspace water under this and proximate lots. *Mhs 4A and 5A were never completed.* **Inactive.**

April snowmelt, sump pump hoses from crawlspace to curb.
