Mh 6A Lot 87. Adelson on East Meadows Drive. This MH has a 2 foot opening with a green plastic cover. The water at this mh was flowing lightly and was at a low level at the inlets and outlet pipes. The inlets to this MH are from 8A and 9A. The outlet is into a diversion PVC pipe to Willow Creek. A ProPipe person operated the Water Jet clearing hose into the inlets and outlets to a distance marked on the HOA's large Underdrain Map, marked in hundreds of feet. The estimated depth of this MH is 6 feet. The steel pipe is sitting on gravel on a cement foundation and ground water from the surrounding area can infiltrate. **ACTIVE.**

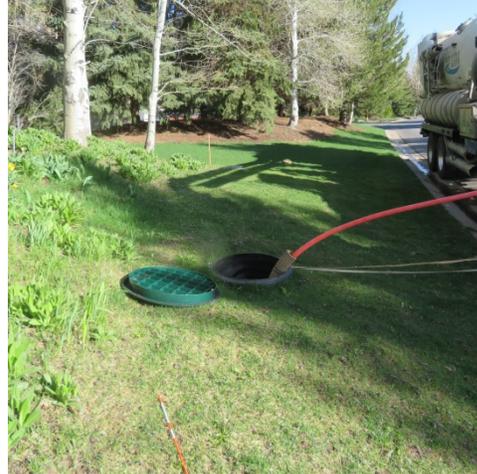
Mh 6A. Two foot diameter green plastic cap.

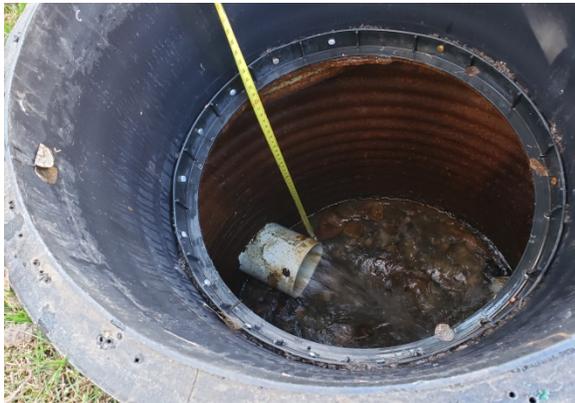
Mh 6A Pro-Pipe clean-out through to Willow Creek.

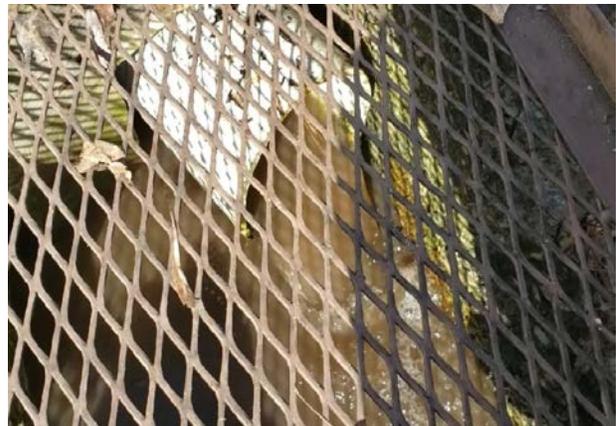
Mh 6A view of interior of steel conduit and white solid PVC outlet pipe. Inflow and outflow in direct oppositional sides. Water depth in conduit is less than six inches. April 4, 2020 inspection.

Segment A's only discharge drain; via Mh 6A outlet through solid PVC discharge pipe in easterly direction, under E. Meadows Drive, between Lot 105 & 106, into Willow Creek. This drain is the only place where the UD water reaches full Daylight.

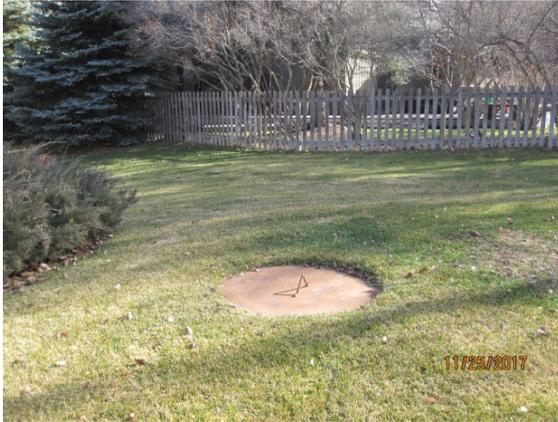
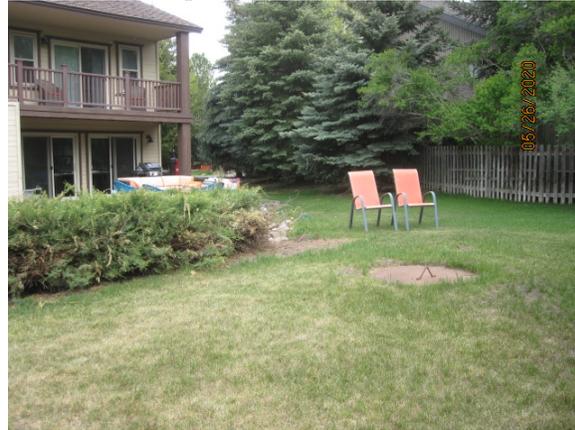
Mh 7A on Lot 88, 4911 East Meadows Drive. Fischer. In Nov. 25, 2014 Alliance Engineering: "The Steel lid is exposed in backyard. Easy to find, at grade." Here are two photos of the large drain cover on Lot 88 near backyard patio, 2017 and 2020. Inflow via perforated tubes 6' to 10' underground, all were installed on 94 private homeowners properties.

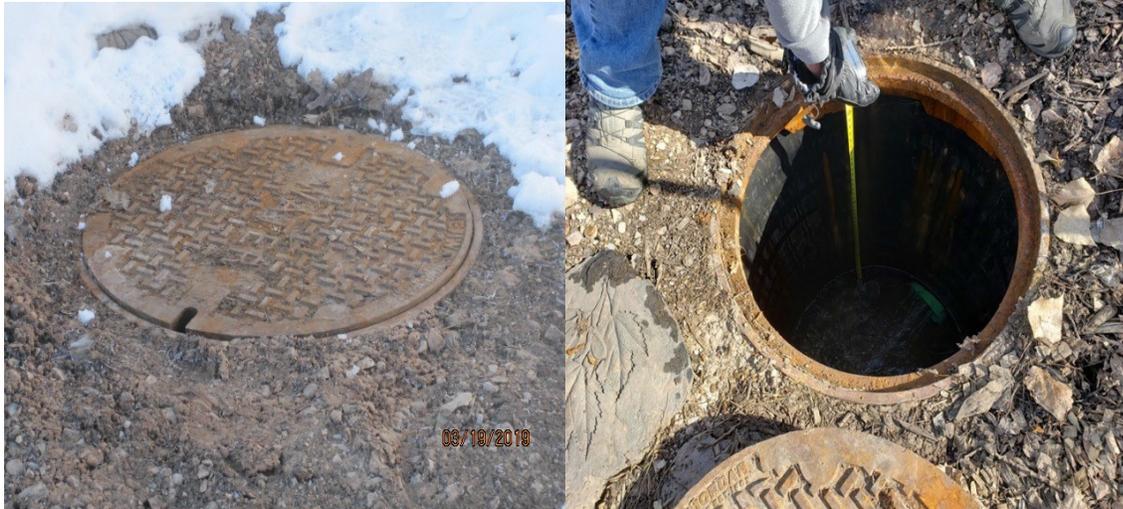
Mh 8A This Mh was added c2017 at Lot 68 Willow Loop near the curb. Lachowitz. It has a 2 foot opening with a steel cover. The water at this Mh was flowing lightly and was at a low level at the inlet and outlet pipes. The inlet to this Mh is from Mh 10A Lot 54. The outlet is into Mh 7A. The ProPipe person operated the Water Jet clearing hose into the inlet and outlet pipes in the Mh. There were a few roots coming out of the inlet pipe into the Mh 8A. There is a great deal of damage to the front yard, now covered with chipped pine bark. **ACTIVE.**

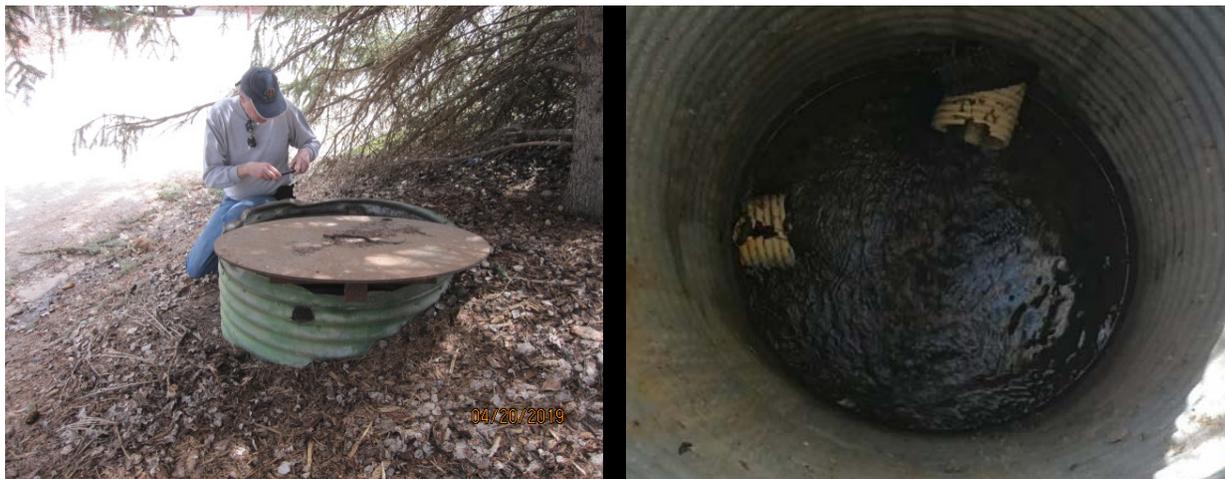
Mh 9A Lot 70. Jon Ball. On Willow Loop. Four foot lid cover and green steel conduit above grade, located 5.3 feet behind the gutter. This mh has a 4 foot opening. The water at this mh was flowing lightly and was at a low level at the inlet and outlet pipes. The inlet is from Mh 16A. Outlet is to Mh 7A, then on to Mh 6A. The ProPipe person operated the Water Jet clearing hose into the inlets and outlets pipes in the Mh. The inlet (and outlet corrugated pipes) into Mh 9A is damaged, how and why is not known. The suspect is the ProPipe jet hose and nozzle, along with the 2000 psi water jet. **ACTIVE.**

Clay measuring height of water in steel conduit.

Height of water less than 6". Damage to tubes.
