STORM DRAIN BOXES on Ranch Place Road. Inspected June 18, 2020 by Clay & Lucy Archer, Bradley Hornsby.

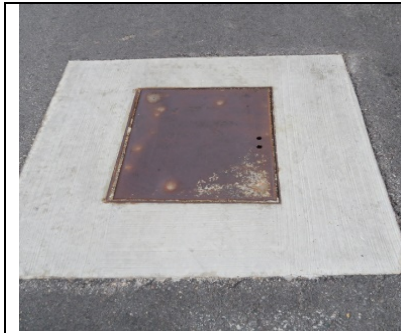
SOUTH SD box near SS Lot 138 SW Corner on Ranch Place (road) and Willow Lane. Square steel lid.

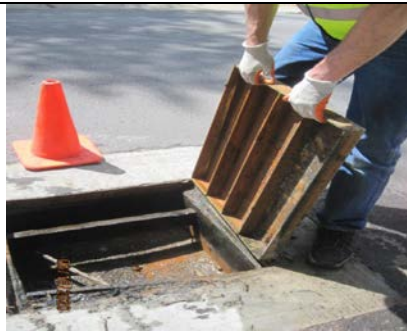
Inside the South SD box- **found completely dry and empty.** Ribbed steel lid. Possible proposed catch basin for Willow Lane.

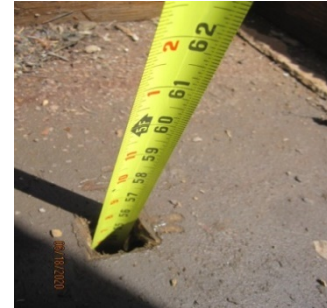
South SD box , 56" from ground to plywood divider + 12" up to road, total 68". **No inlets or outlets.**

The Segment B SOUTH SD BOX steel cover, surrounded by a 48" by 52" cement collar, set into the 2019 resurfaced asphalt street was lifted out. Under the cover we found a cement infused wood form, and a plywood platform installed parallel to the lid. A hole in the plywood divider platform allowed us to measure the total depth of this storm drain, found to be 68 inches.

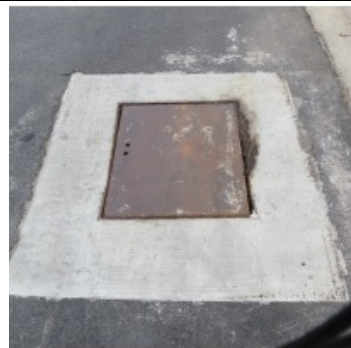
NORTH SD Box – 130' north from South SD Box. In front of Lot 154. May be catch basins for this road.

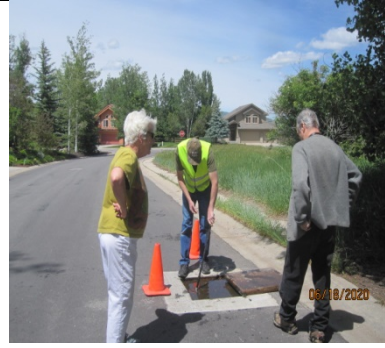
Inside North SD Box – **found it full of murky, immiscible street water.** 30" from ground to plywood divider; 14" from plywood to road. Total 44".

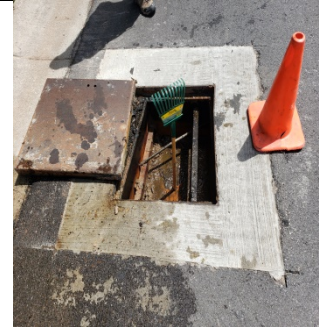
Inside of north SD Box. Stagnant, stinky, murky water was scooped out and also drained. **No visible inlets or outlets.**
