MAY 4, 2020 SSSF MAN HOLE INSPECTION and PRO PIPE CLEAN OUT - SEVEN "PHASE A" MAN HOLES

Report was written by Bradley Hornsby. Photos by Clay & Lucy Archer and Bradley Hornsby.

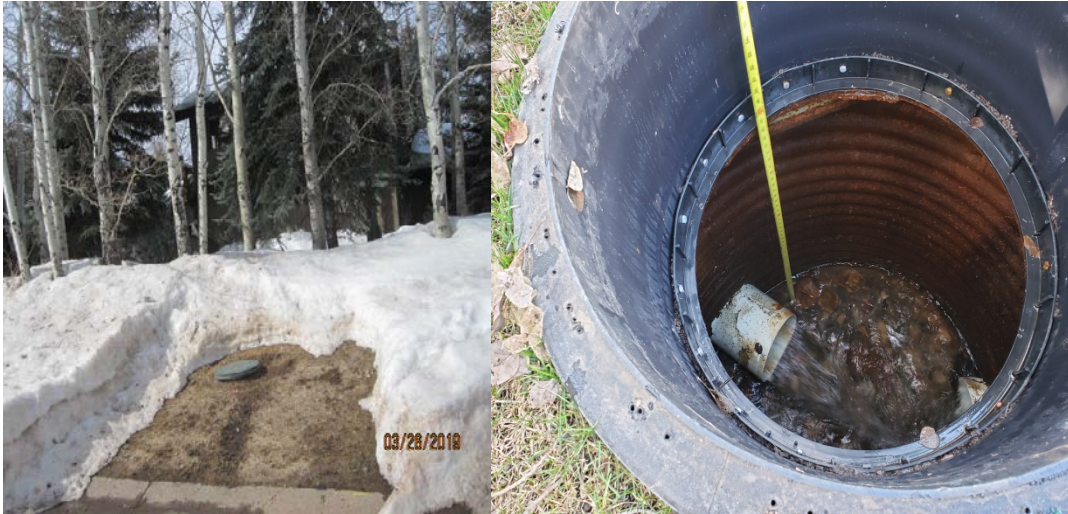
1. MH 6A

This MH has a 2 foot opening with a Green Cover. The water at this MH was flowing lightly and was at a low level at the inlets and outlet pipes. The inlets to this MH are from 5A and 7A. The outlet is into a stream. See pictures MH6A1, MH6ASTREAMOUTLET1, MH6ASTREAMOUTLET2, and MH6ACATCH. A ProPipe person operated the Water Jet clearing hose into the inlets and outlets pipes to a distance provided by Bill Noland and his Underdrain Map, hundreds of feet. The estimated depth of this MH is 6 feet. The steel pipe is sitting on a cement foundation and ground water from the surrounding area can infiltrate.

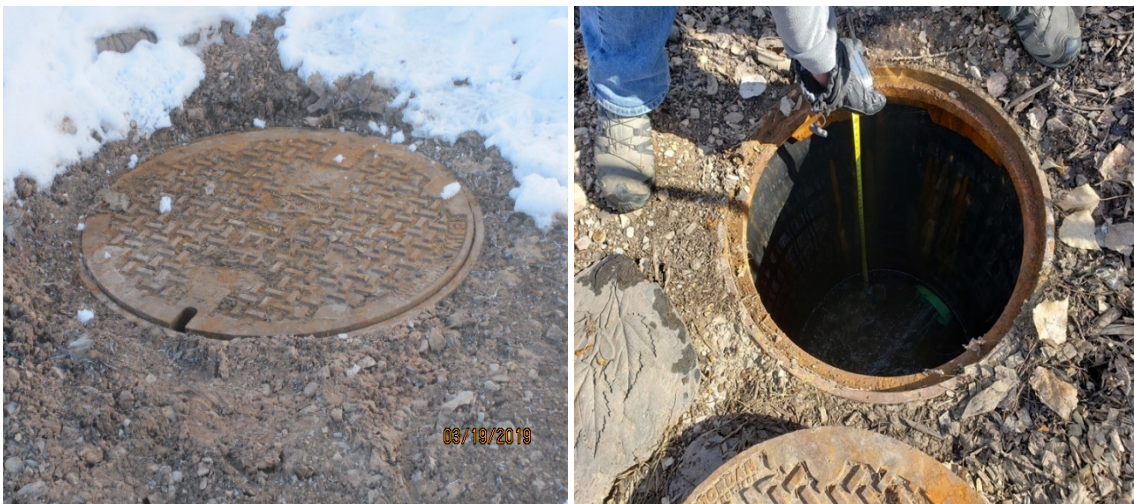
2. MH 8A

This MH has a 2 foot opening with a Steel Cover. The water at this MH was flowing lightly and was at a low level at the inlet and outlet pipes. The inlet to this MH are from MH 10A. The outlet is into MH 7A. See pictures MH8A1. The ProPipe person operated the Water Jet clearing hose into the inlets and outlets pipes in the MA. There were some tree roots coming out of the inlet pipe into the MH 8A.

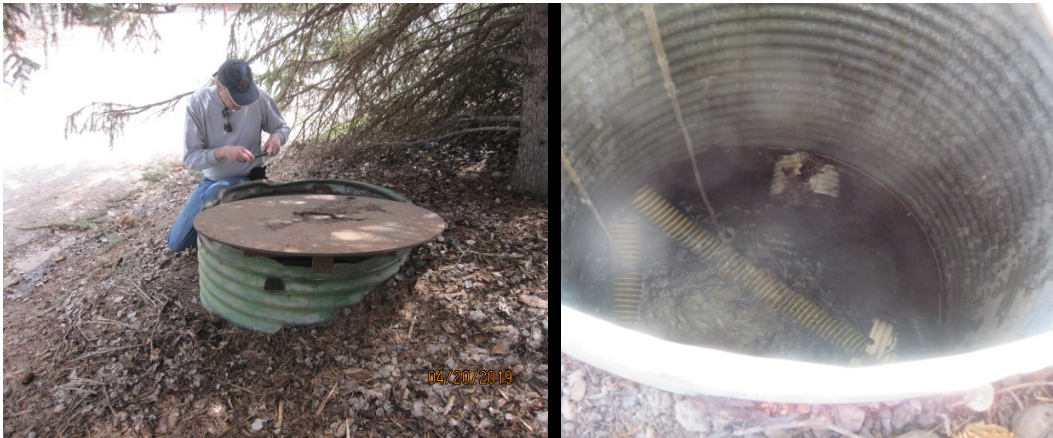
3. MH 9A

This MH has a 4 foot opening with a Steel Cover. The water at this MH was flowing lightly and was at a low level at the inlet and outlet pipes. The inlet to this MH are from MH 16A. The outlet is into MH 7A. See pictures MH9A1 and MH9A2. The ProPipe person operated the Water Jet clearing hose into the inlets and outlets pipes in the MA. The inlet pipe into MH 9A is damaged, how and why is not known. The suspect is the ProPipe jet hose and nozzle.

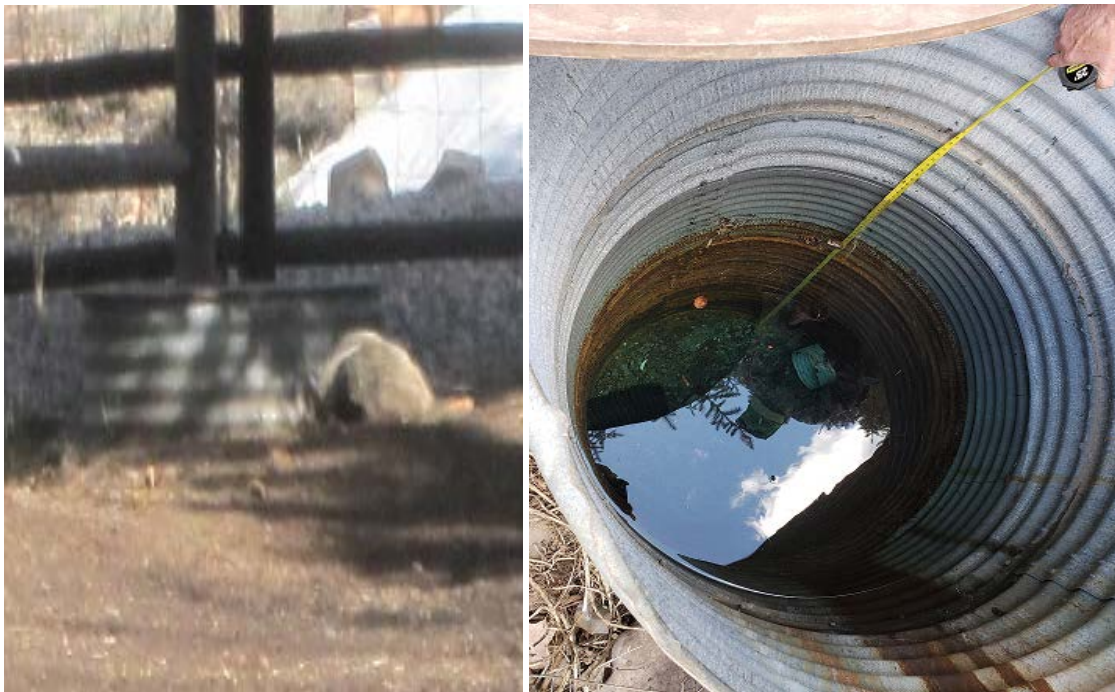
4. MH 10A

This MH has a 4 foot opening with a Steel Cover. The MH is at the east end of the back yard of Lot 54, on Silver Springs Road. The water at this MH was flowing lightly [dropped more approx. 60" from the April 4, 2020 inspection of 82"] and was at a low level at the inlet and outlet pipes. The inlet to this MH are from MH 11A. The outlet is into MH 8A. See pictures MH10A1. The ProPipe water jet was not used at this location.

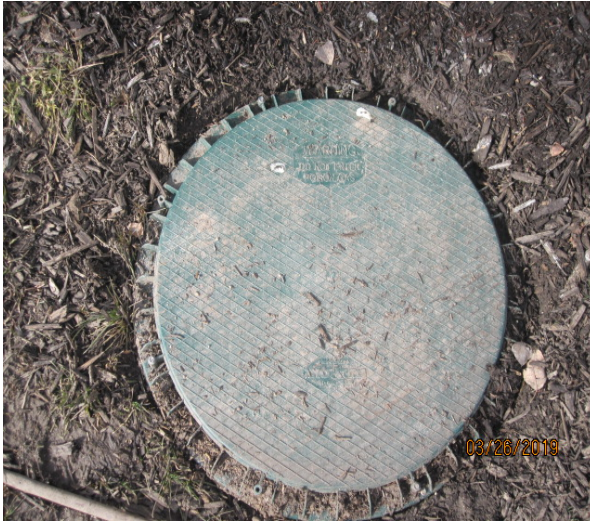
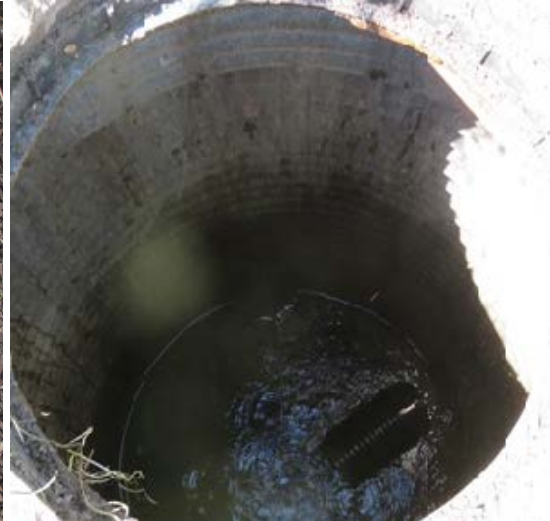
5. MH 11A

This MH has a 2 foot opening with a Green Cover. The water at this MH was flowing lightly and was at a low level at the inlet and outlet pipes. The inlet to this MH is from MH 12A. The outlet is into MH 10A. The ProPipe person operated the Water Jet clearing hose into the inlets and outlets pipes in the MH. The outlet pipe going to MH10A was broken and lying in the bottom of MH 11A, see picture MH11A. Not sure if outlet pipe was broken at this time or in the past. A discussion was held with Bill Noland whether trenches and ditches were covered up. Bill said all were covered when this subdivision's infrastructure was completed in 1982.

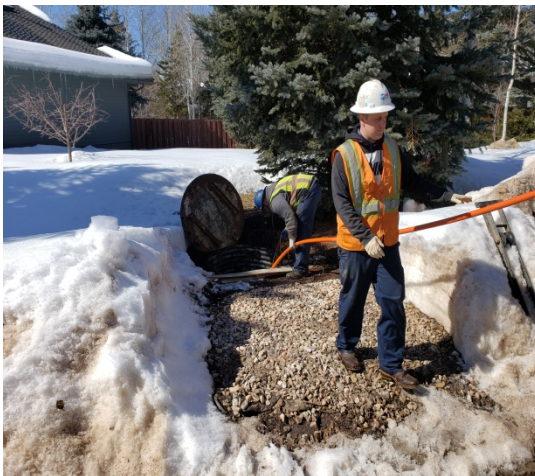
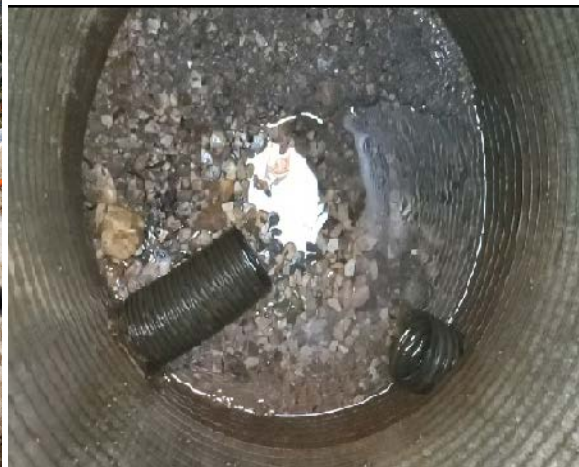
6. MH 15A

I did not attend the procedure at MH 15A. I assume the results are the same as others. The inlet to this MH are from MH 14A. The outlet is into MH 16A.

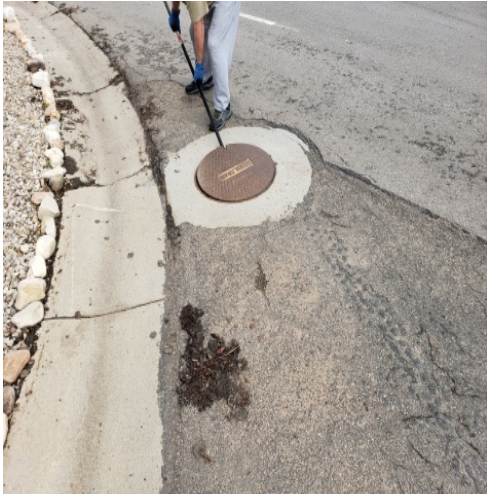
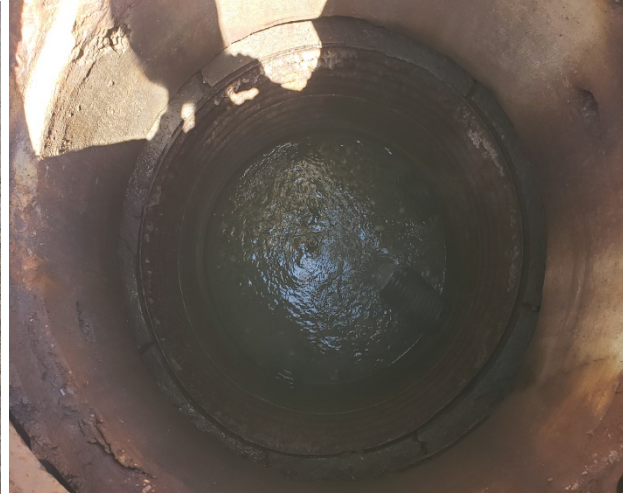
7. MH 16A

This MH has a 2 foot opening with a Steel Cover located in the street, the corner of Lake Front Ct and Silver Spring Road. The water at this MH was flowing lightly and was at a low level at the inlet and outlet pipes. The inlets to this MH are from MH 15A and 17A. The outlet is into MH 9A. The ProPipe person operated the Water Jet clearing hose into the inlets and outlets pipes in the MH. The ProPipe person when operating the Water Jet in the inlet pipe from MH17A thought he was running into a blockage, but now believes he was trying to go uphill to MH17A on Lake Front Court and that was what was creating the appearance of a blockage.
