# Sun Peak Master Association

## Level 1 Reserve Study

**Report Period – 01/01/2014 – 12/31/2014**

<b>Date of Property Inspection</b>	<b>8/30/2013</b>
<b>Prepared By</b>	<b>Dale Gifford</b>
<b>Analysis Method</b>	<b>Cash Flow</b>
<b>Funding Goal</b>	<b>Full Funding</b>

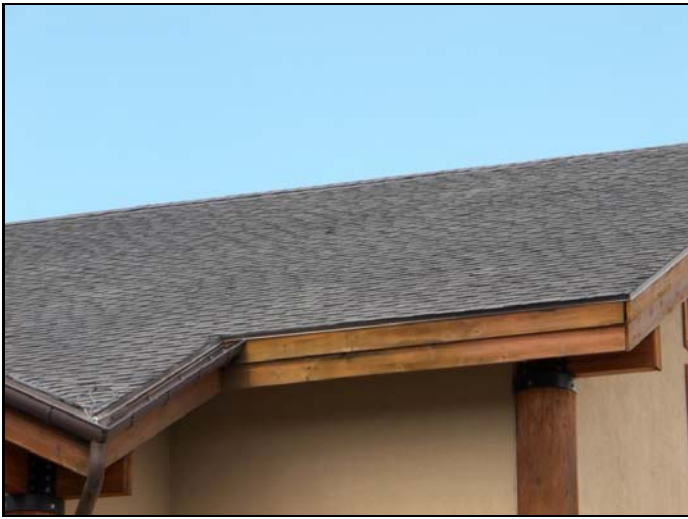
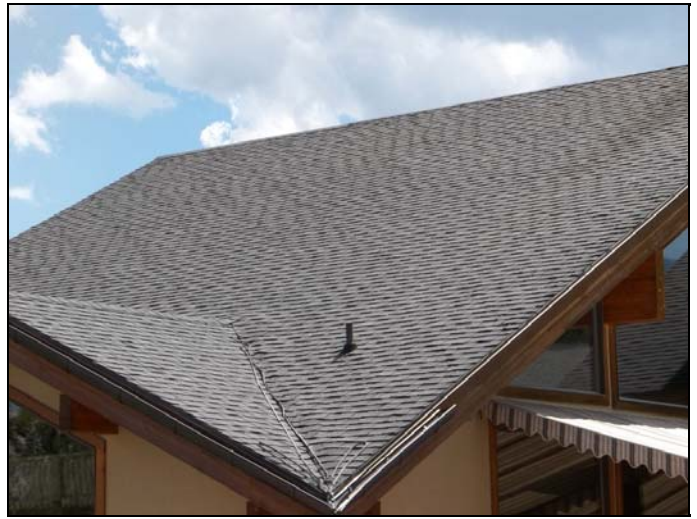
Comp #: 105 Pitched Roof - Clubhouse & Shed - Replace

The roof is in good condition. No problems were noted or reported at the time of the inspection. Typically this type of roofing material has a useful life of approximately 25 years. Inspect roofs regularly and make local repairs as necessary as an operating expense to ensure full life from this component. Remaining life based on current age.

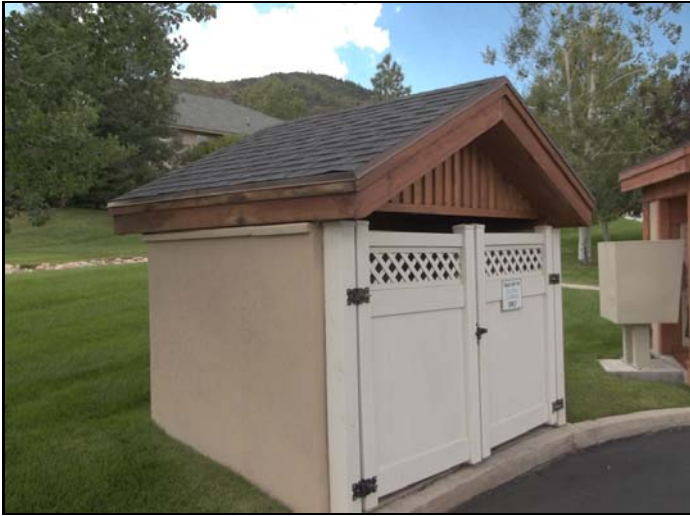
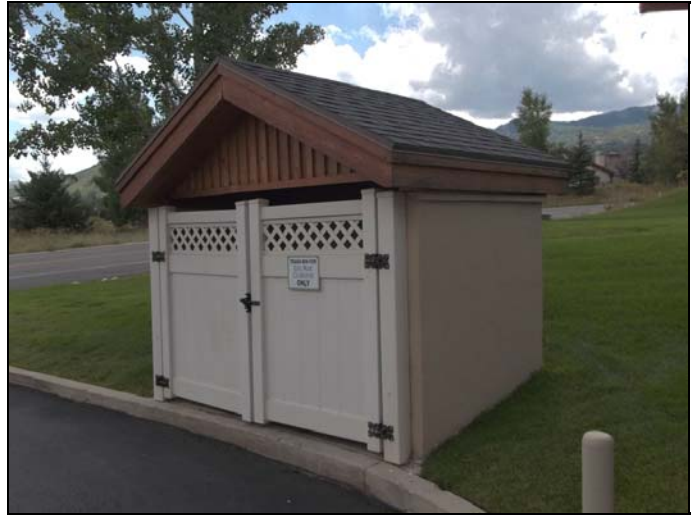
Comp #: 105 Pitched Roof - Garbage Enclosure - Replace

The garbage enclosure roof is in good condition. Due the minimal cost of replacing this component, reserve funding is not appropriate. Replace as necessary as an operating expense. No reserve funding necessary.

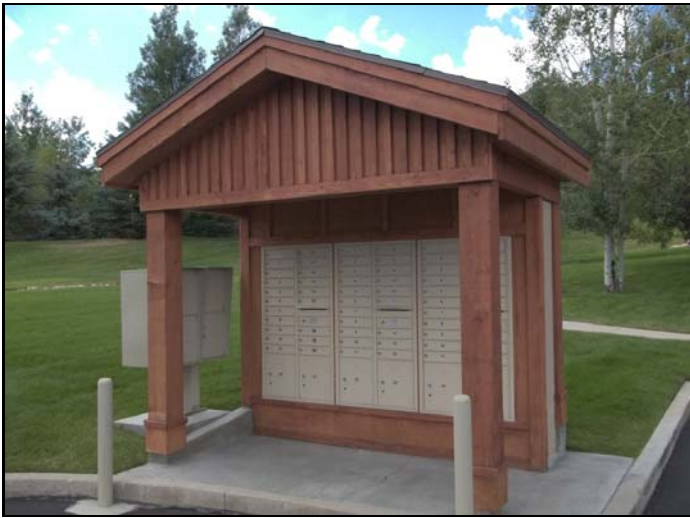
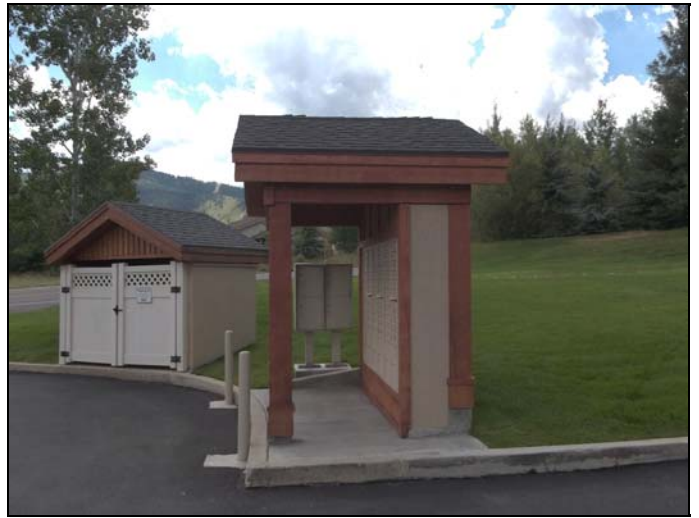
Comp #: 105 Pitched Roof - Mailbox Kiosk - Replace

The mailbox kiosk roof is in good condition. Due the minimal cost of replacing this component, reserve funding is not appropriate. Replace as necessary as an operating expense. No reserve funding necessary.

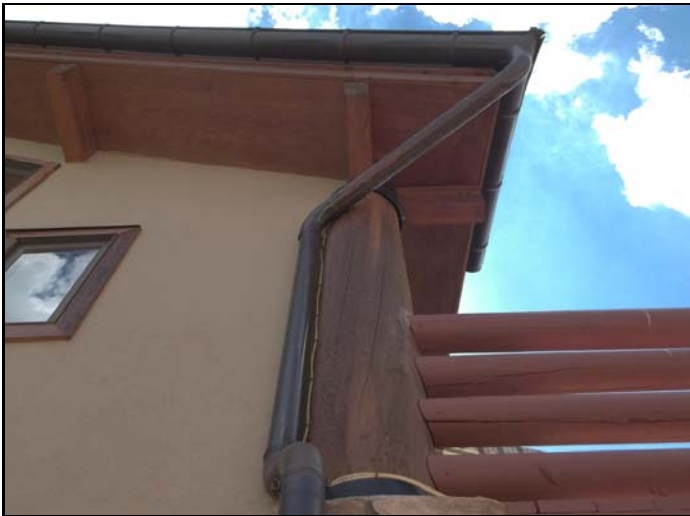
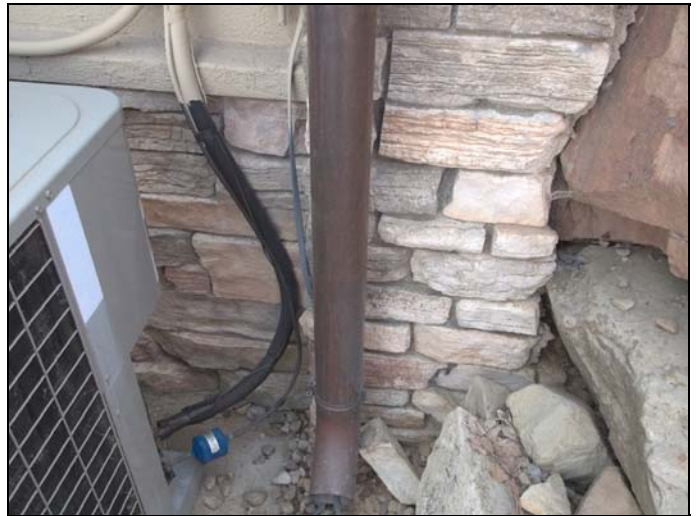
Comp #: 120 Rain Gutters/Downspouts - Replace

The rain gutter/downspouts are generally in good condition. This component has an extended useful life. No reserve funding necessary.

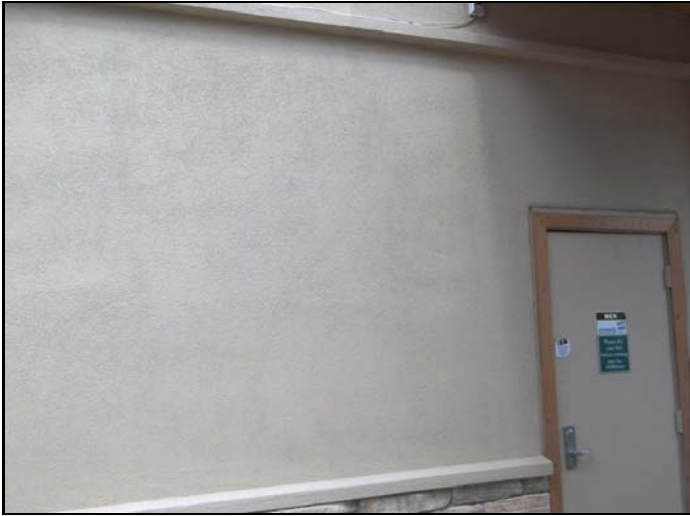
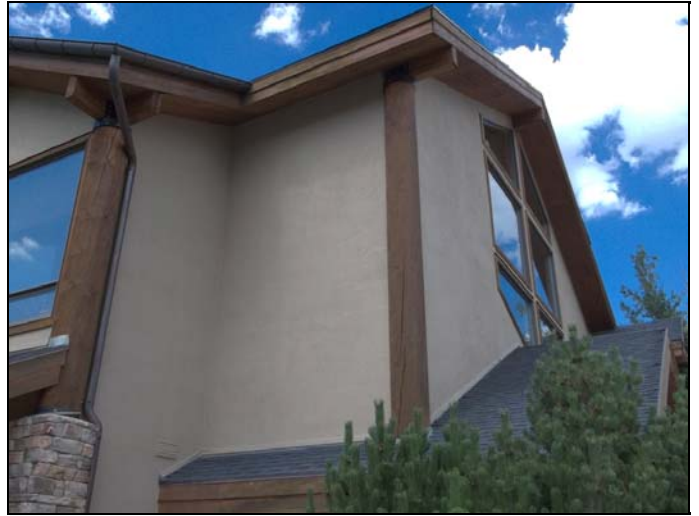
Comp #: 201 Stucco Surfaces - Repair/Repaint

The stucco surfaces are in fair condition. Minor discoloration were noted at the time of the inspection. We recommend funding to repair/repaint this component approximately every 10 - 12 years to protect the stucco surface and maintain appearance. Remaining life based on current age.
