## *Underdrain Inspection on April 4, 2020 – Clay and Russ*

**Link to: [Several Maps for the underdrains, all located on SSSF private Homeowner property.](#)**

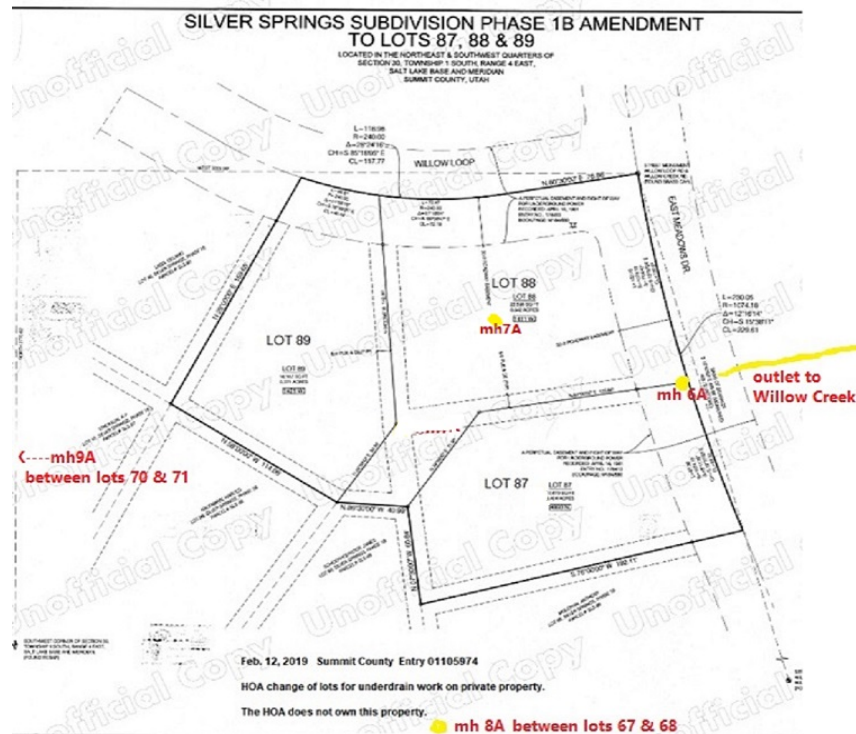
Leaving MH 6A, water outflow through PVC drainpipe under East Meadows Dr., then between Lots 105 and 106, moves water to Willow Creek.

Summit County in 2019 recorded a Plat Amendment that changed the configuration of Lots 87, 88, 89.
