Mh 6A Lot 87. Adelson on East Meadows Drive. This MH has a 2 foot opening with a green plastic cover. The water at this mh was flowing lightly and was at a low level at the inlets and outlet pipes. The inlets to this MH are from 8A and 9A. The outlet is into a diversion PVC pipe to Willow Creek. A ProPipe person operated the Water Jet clearing hose into the inlets and outlets to a distance marked on the HOA's large Underdrain Map, marked in hundreds of feet. The estimated depth of this MH is 6 feet. The steel pipe is sitting on gravel on a cement foundation and ground water from the surrounding area can infiltrate. **ACTIVE.**

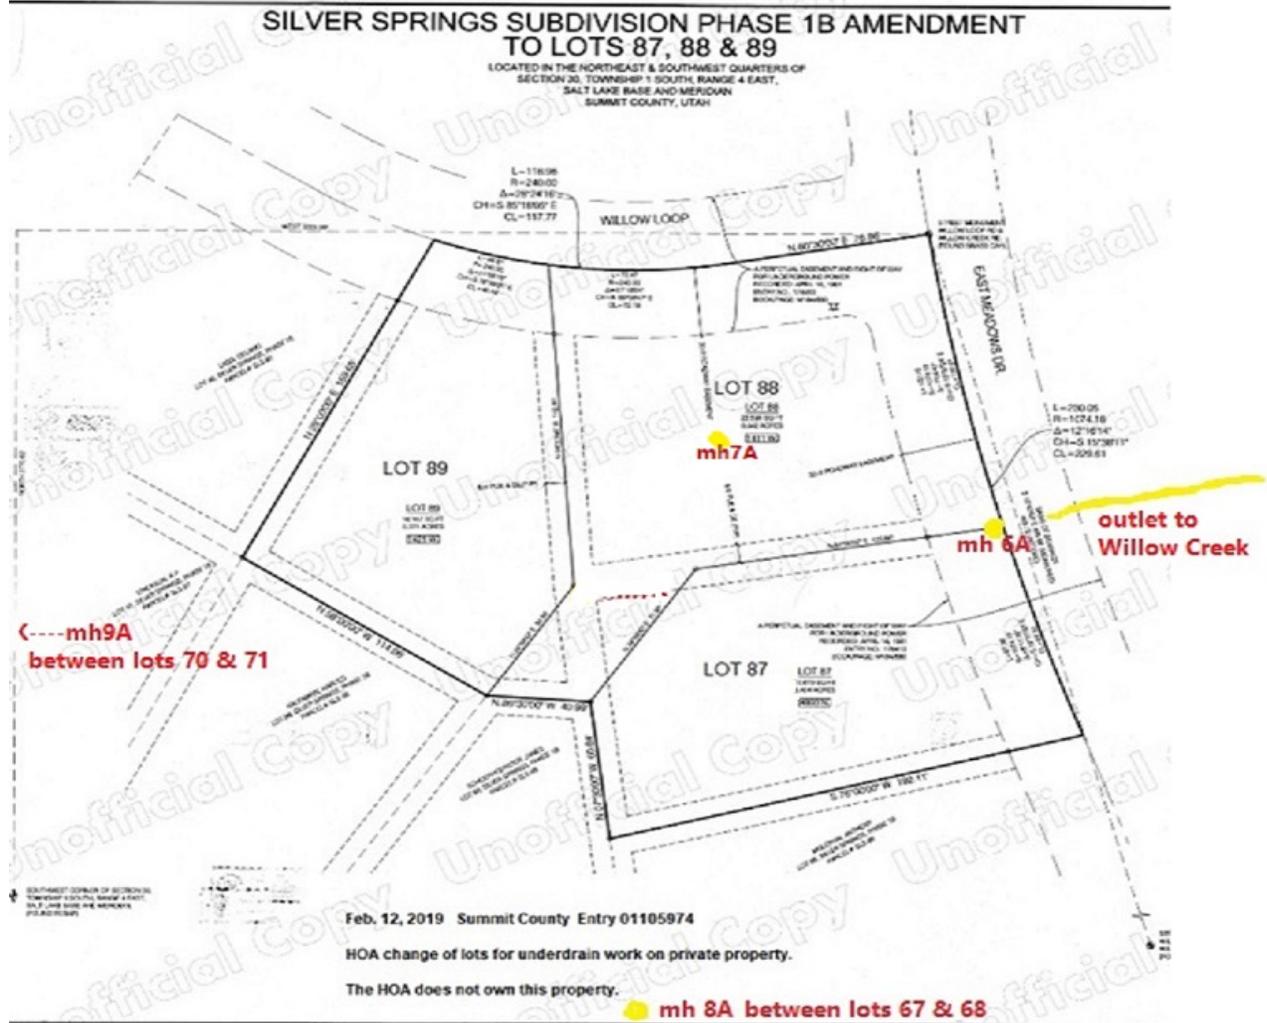
The County has a recorded Plat Amendment on February 12, 2019 for Lots 87-88-89.

Entry 01105974 Exhibit indicates street location. Also see plat map below:
