# Sun Peak Master Association

## Level 1 Reserve Study

**Report Period – 01/01/2014 – 12/31/2014**

<b>Date of Property Inspection</b>	<b>8/30/2013</b>
<b>Prepared By</b>	<b>Dale Gifford</b>
<b>Analysis Method</b>	<b>Cash Flow</b>
<b>Funding Goal</b>	<b>Full Funding</b>

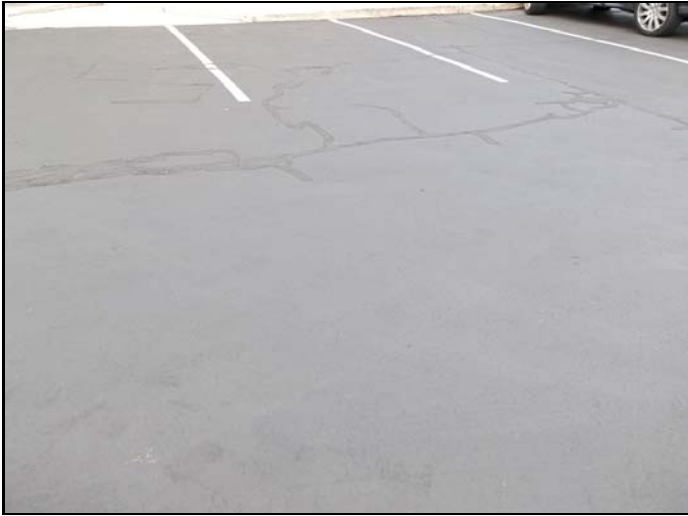
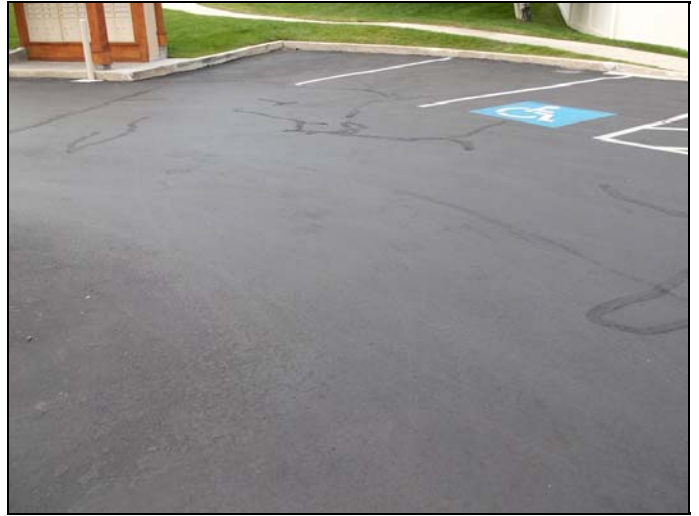
Comp #: 401 Asphalt - Overlay

The asphalt parking lot is in good condition. Minor cracking was noted at the time of the inspection. Asphalt overlay generally has a useful life of 20 - 25 years. Maintain seal coat schedule to ensure full useful life (see Comp# 402 Asphalt - Seal Coat). Remaining life based on current age.

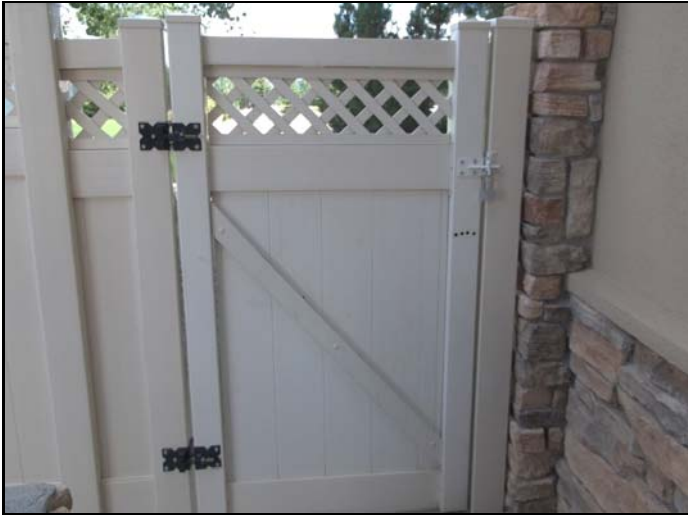
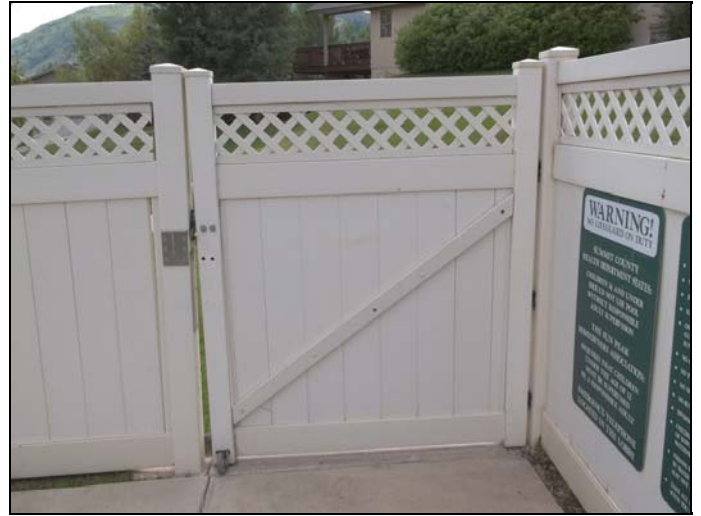
Comp #: 1090 Fence Gates - Replace

The fence gates are in working condition. No problems were noted at the time of the inspection. Research with the client reveals plans to replace this component every 10 years. Remaining life based on current average age.

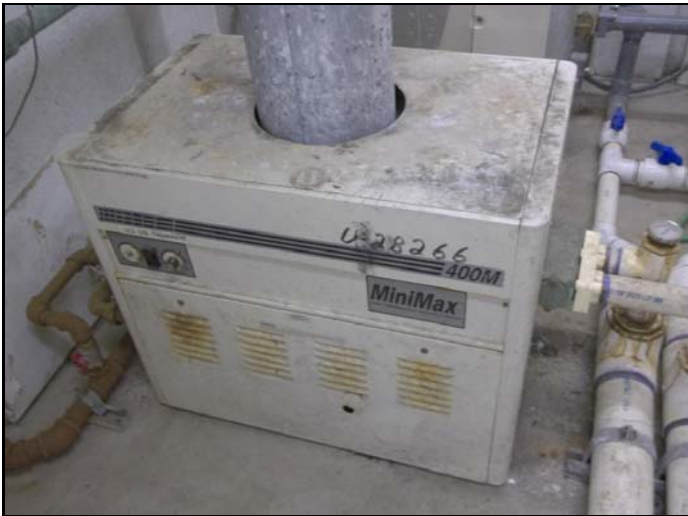
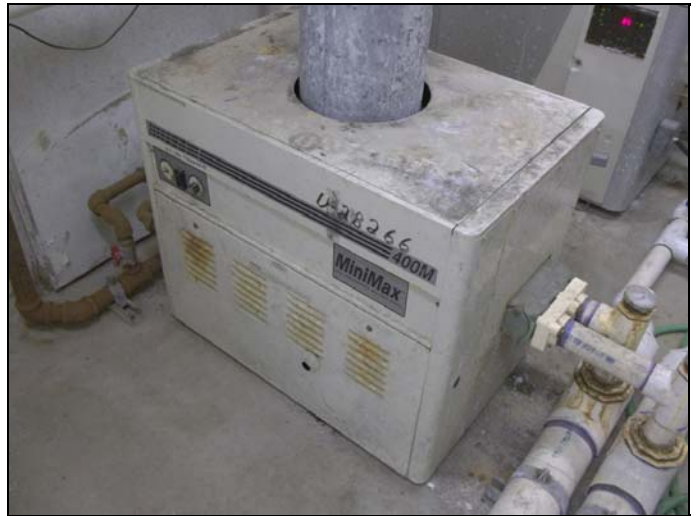
Comp #: 1104 Pool Heater - Older - Replace

The pool heater is in working condition but has passed its useful life. We recommend funding to replace this component in the next few years. This type of heater typically has a useful life of approximately 12 years. Remaining life based on current age.

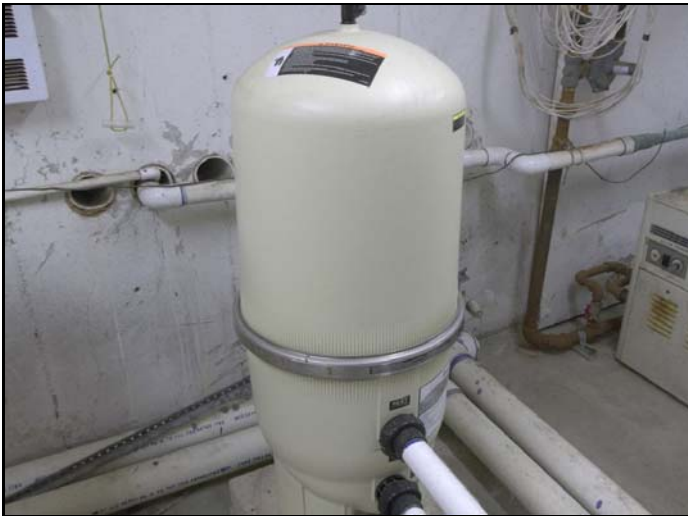
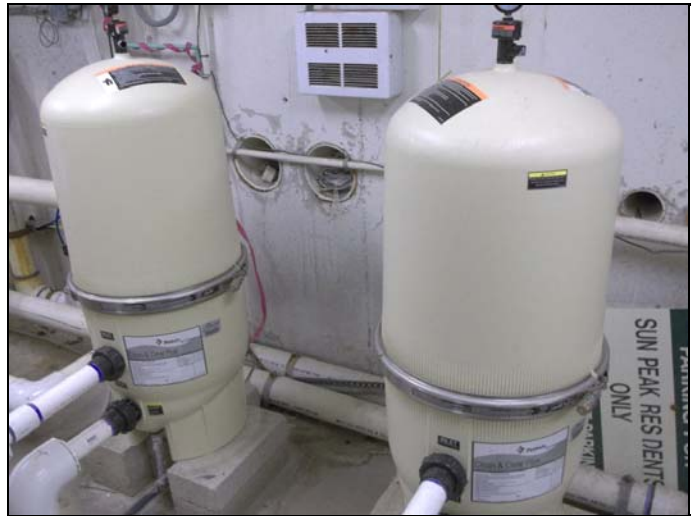
Comp #: 1107 Pool Filters - Replace

The pool filters are in good condition. No problems were noted or reported at the time of the inspection. This type of filter has a life expectancy of approximately 12 - 15 years. Remaining life based on current age.

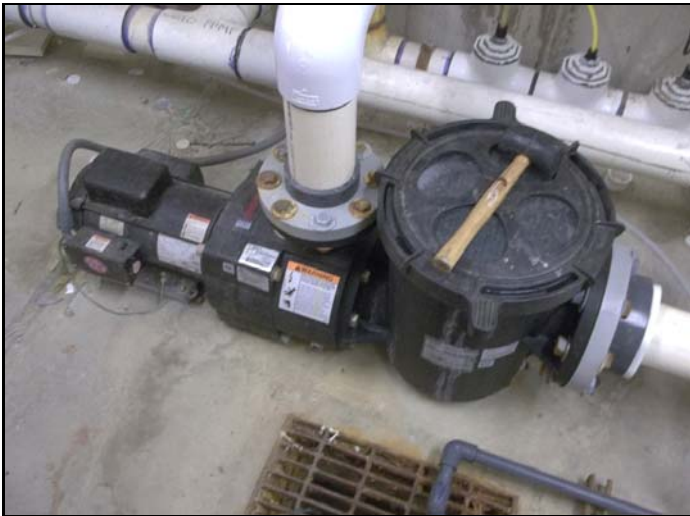
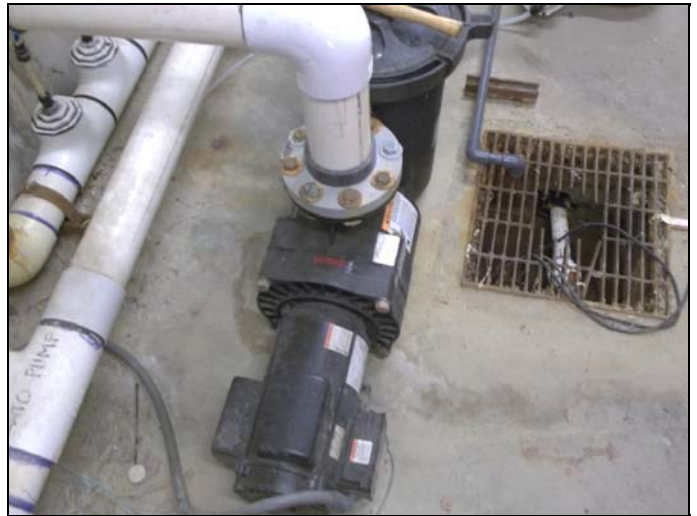
Comp #: 1110 Pool Pump - Replace

The pool pump is in good condition. No problems were noted or reported at time of the inspection. Research with the client reveals a spare pool pump is on site and ready to be installed. We have adjusted the remaining useful life to replace a spare pump has already been purchased. We recommend funding to replace this component approximately every 8 - 10 years. Remaining life based on current age.

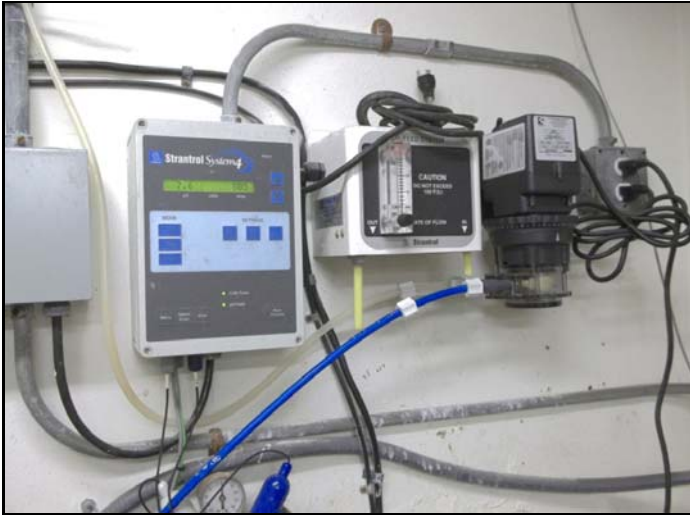
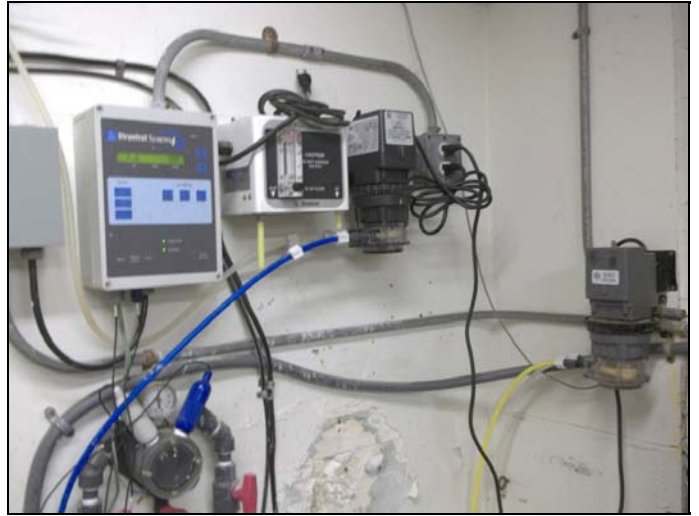
Comp #: 1111 Pool Chemical Controller System - Replace

The pool chemical controller system is in working condition. No problems were noted or reported at time of the inspection. We recommend funding to replace this system approximately every 10 - 12 years to ensure proper function and to keep up with current technology. Remaining life based on current condition.

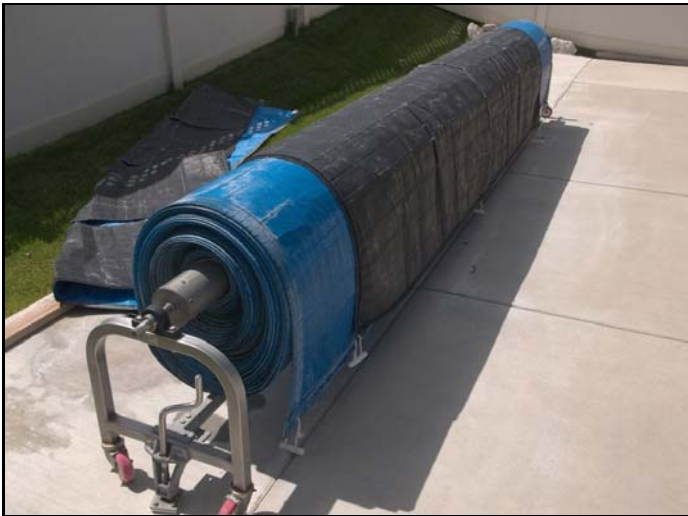
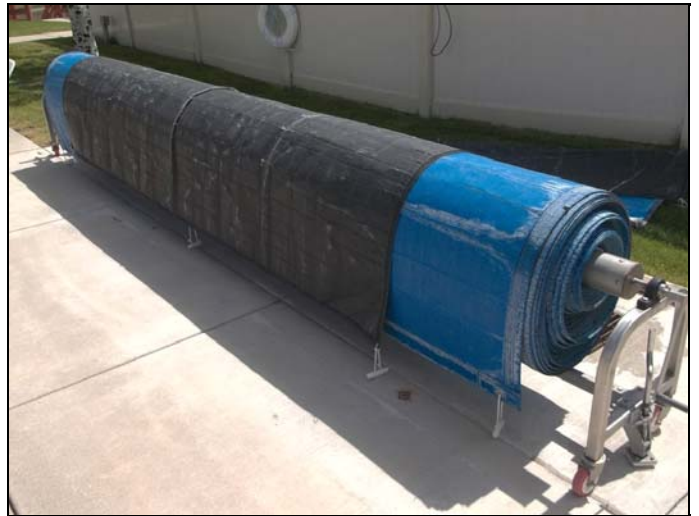
Comp #: 1112 Pool Cover - Summer - Replace

The pool cover appears to be in good to fair condition. We recommend funding to replace this cover every 10 years. Remaining life based on current age.

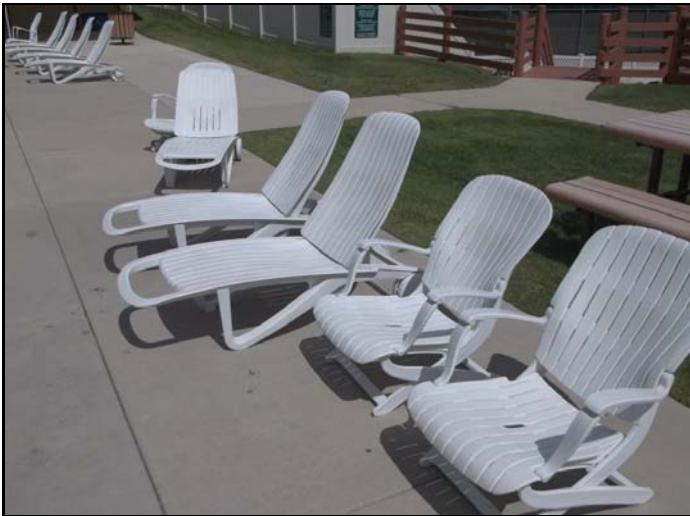
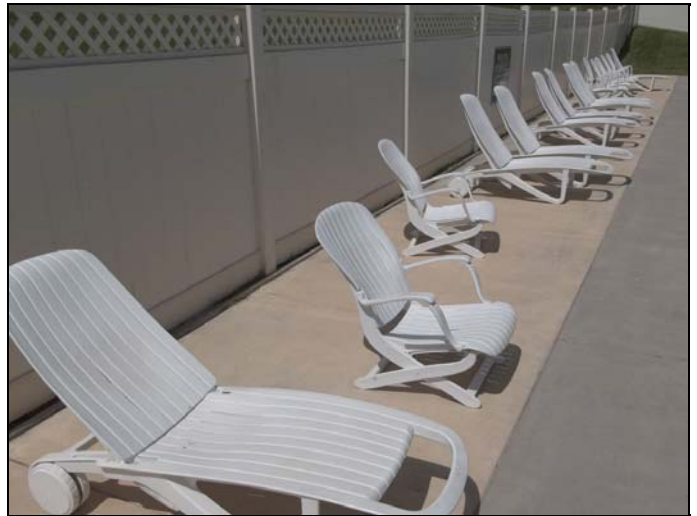
Comp #: 1121 Pool Furniture - Replace

The pool furniture is in fair condition. No appearance concerns were noted at the time of the inspection. Expect a useful life of approximately 6 years from this component. Remaining life based on current condition.

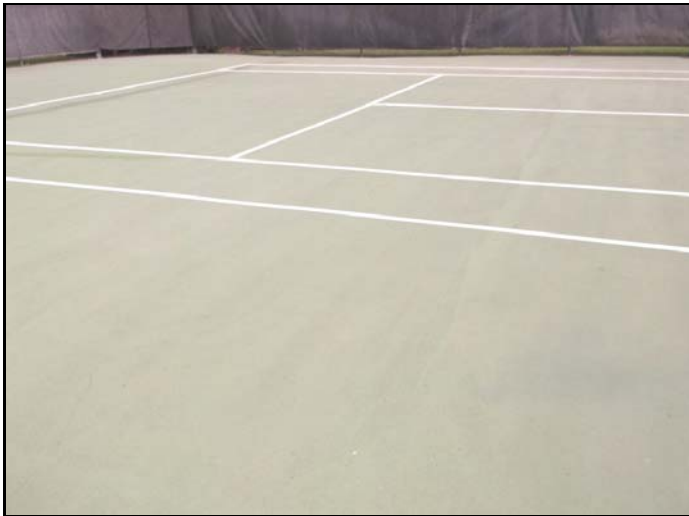
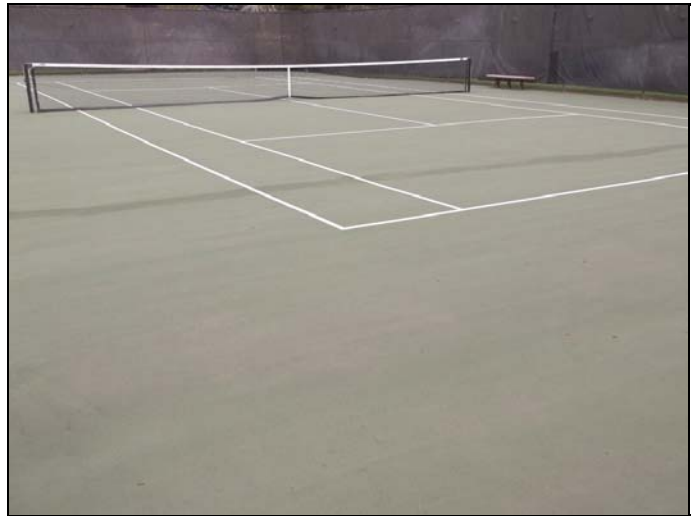
Comp #: 1201 Tennis Court Surface - Repair/Resurface

The tennis court surface is in fair to poor condition. Research with the client reveals plans to overlay/resurface this component in fiscal year 2014. The remaining useful life reflects this overlay/resurface job that will be completed in fiscal year 2014. Expect to resurface this component approximately every 10 - 15 years assuming normal use and wear. Remaining life based on current age.

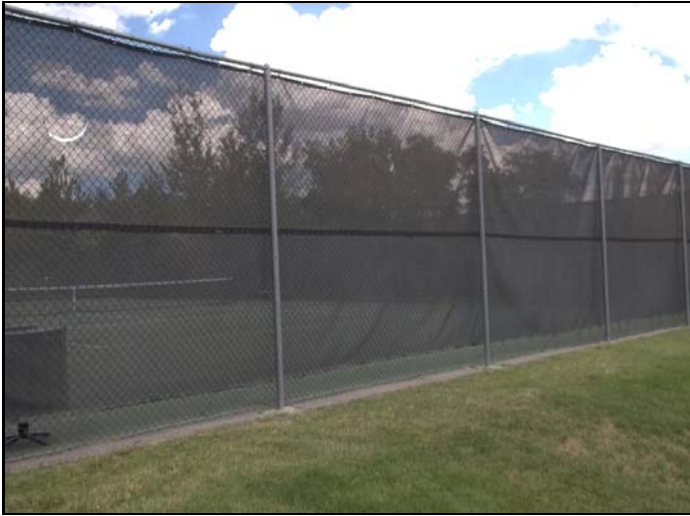
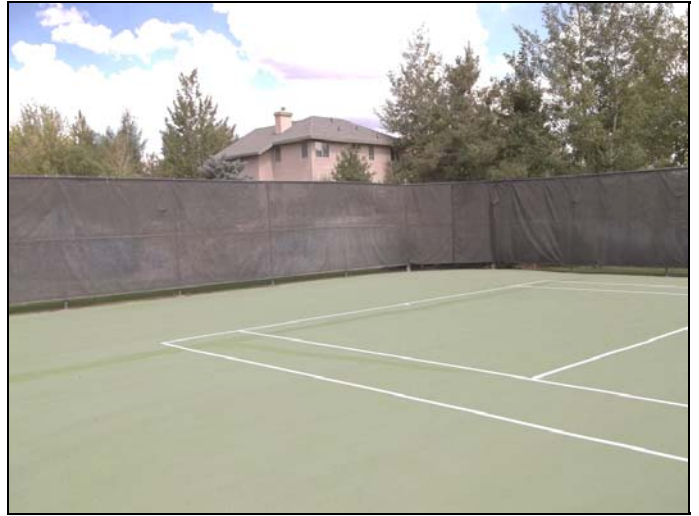
Comp #: 1202 Tennis Court Windscreen - Replace

The windscreen is in good condition. No damage was noted at the time of inspection. We recommend funding to replace this component approximately every 8 - 10 years. Remaining life based on current condition.

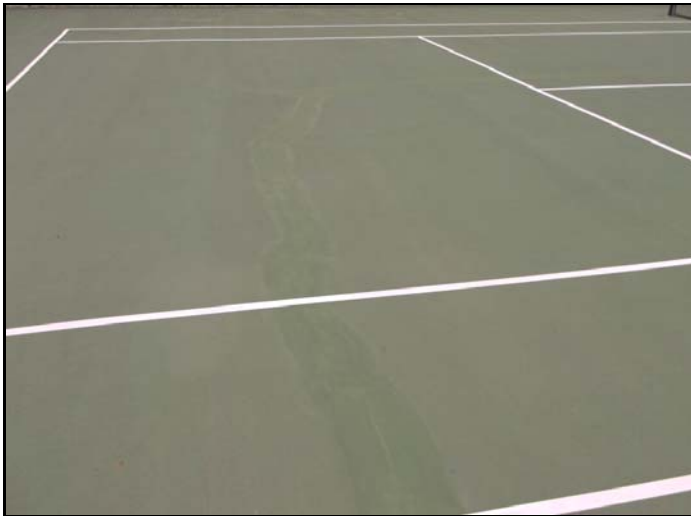
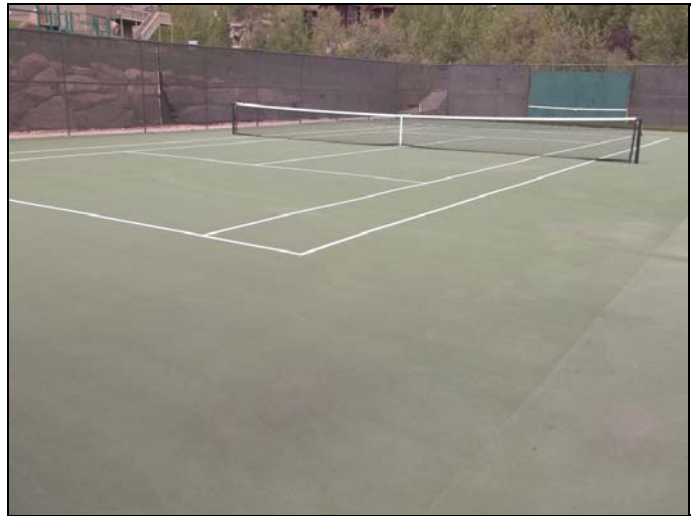
Comp #: 1203 Tennis Court Asphalt - Overlay/Resurface

The tennis court asphalt surface is in fair to poor condition. Research with the client reveals plans to overlay/resurface this component in fiscal year 2014. We recommend funding to replace this component proximally every 20 - 25 years. Remaining live based on current condition.

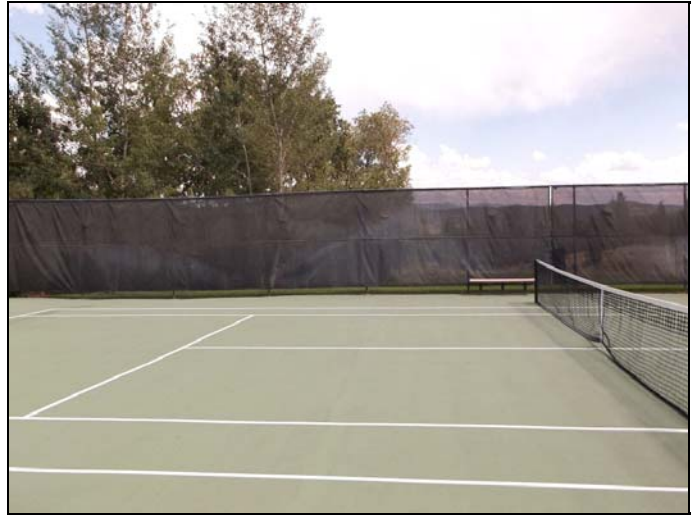
Comp #: 1290 Tennis Court Fence - Replace

The chain link fence is in fair to poor condition. One side sagging was noted at the time of the inspection. The initial replacement of the fence is going to be more expensive than future replacements due to the need to install concrete footings for the fence posts. Expect to replace this component approximately every 20 - 25 years. Remaining life based on current age.

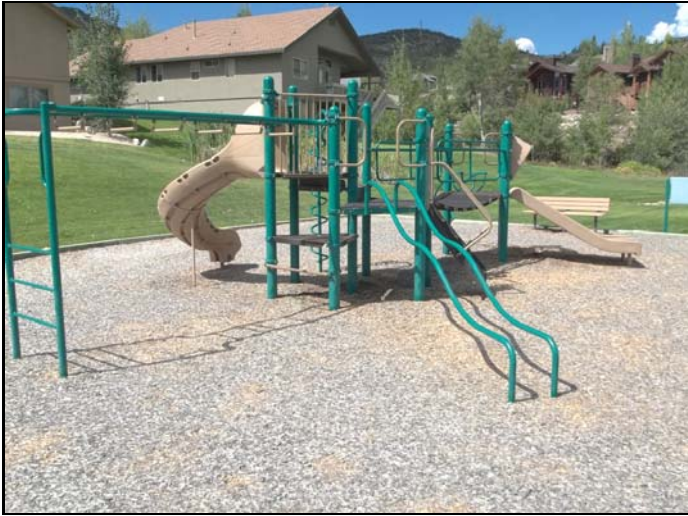
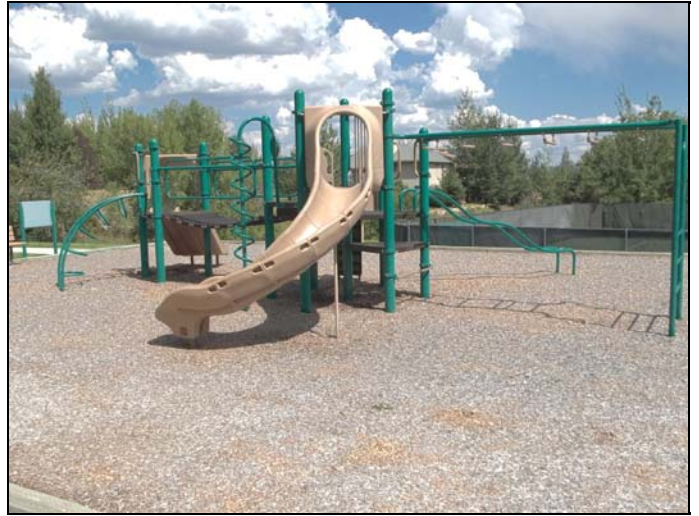
Comp #: 1301 Play Structure - Replace

The play structure is in good condition. No significant signs of wear or damage were noted at the time of the inspection. Expect a useful life of approximately 20 - 25 years from this component. Remaining life based on current age and condition.

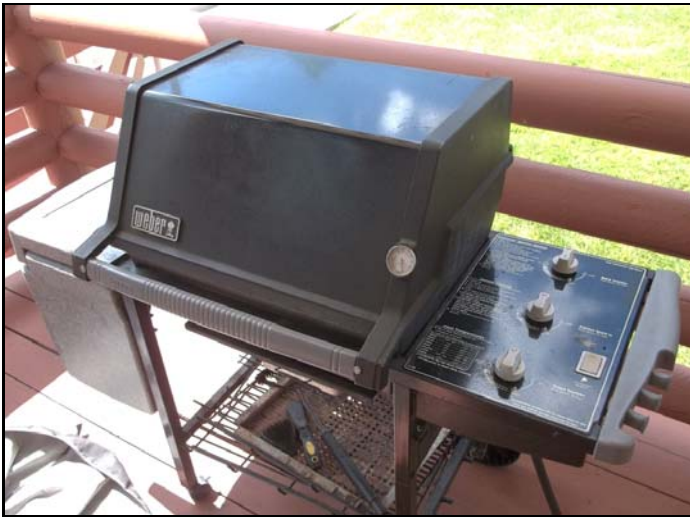
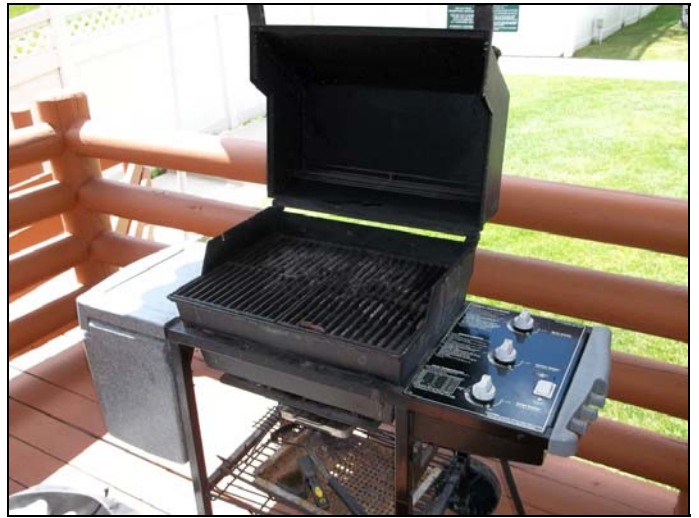
Comp #: 1305 Barbecue Grill - Replace

Research with the client reveals this component will be replaced in fiscal year 2014. We recommend funding to replace this component approximately every 8 - 10 years. Remaining life based on current age.

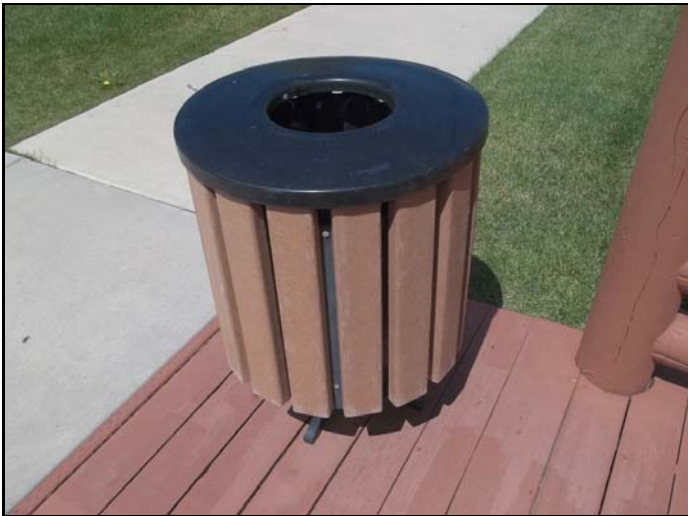
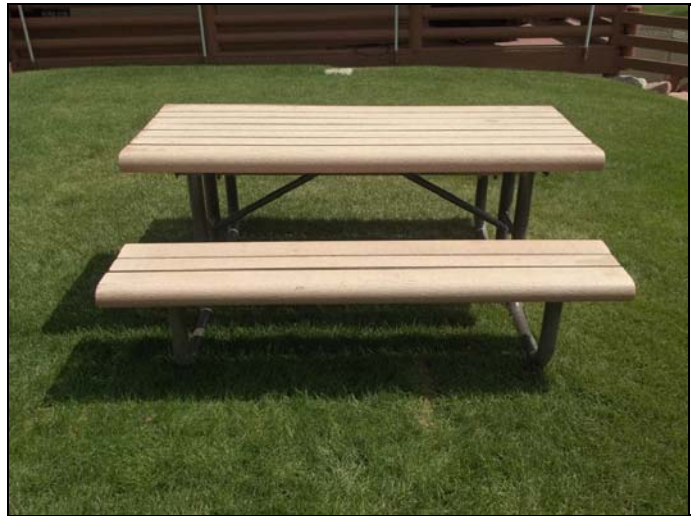
Comp #: 1307 Park Furniture - Replace

The park furniture is in fair condition. No problems were noted at the time of the inspection. Expect a useful life of approximately 10 - 12 years from this component. Remaining life based on current average age.

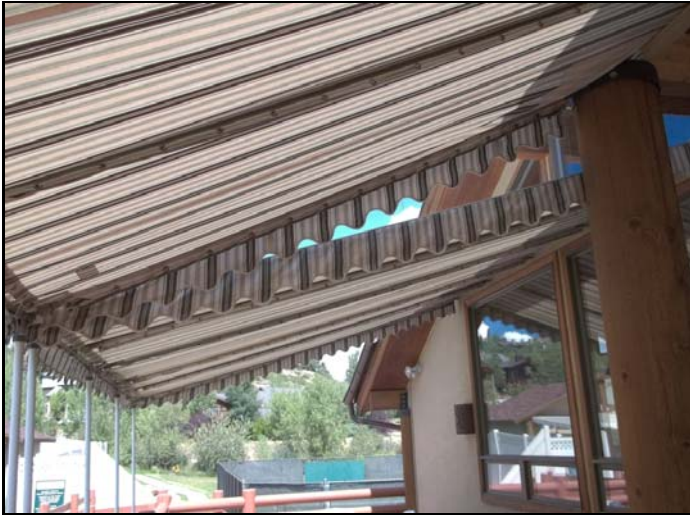
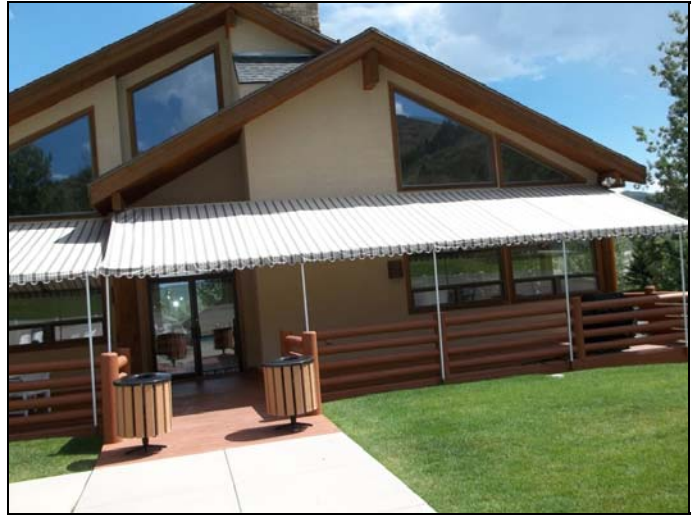
Comp #: 1312 Clubhouse Awning - Replace

The clubhouse awnings are in poor condition. Research with the client reveals this component will be replaced in fiscal year 2014. We recommend funding to replace this component approximately every 8 - 10 year. Remaining life based on current condition.

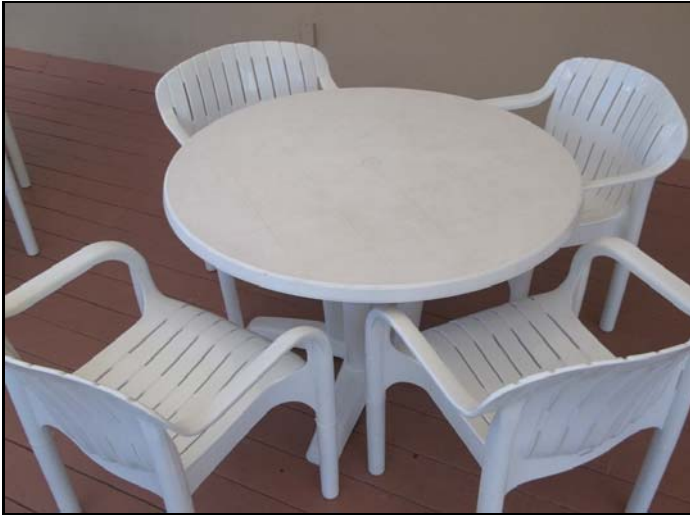
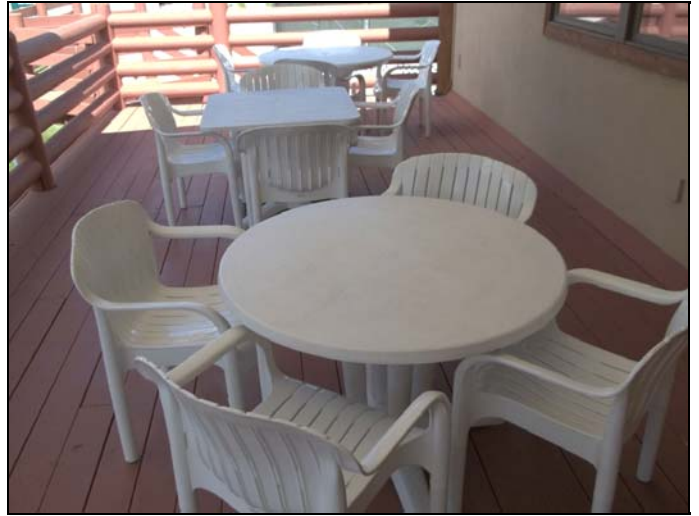
Comp #: 1390 Patio Furniture - Replace

The patio furniture is in fair condition. No problems were noted at the time of the inspection. Expect a useful life of approximately 8 - 10 years from this component. Remaining life based on current age.

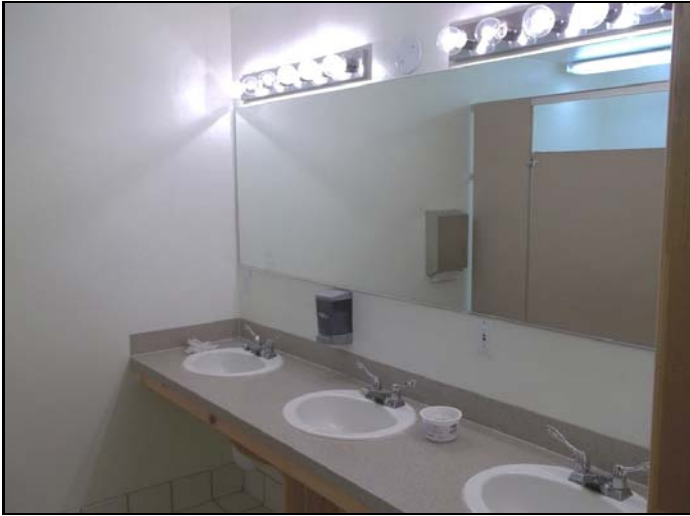
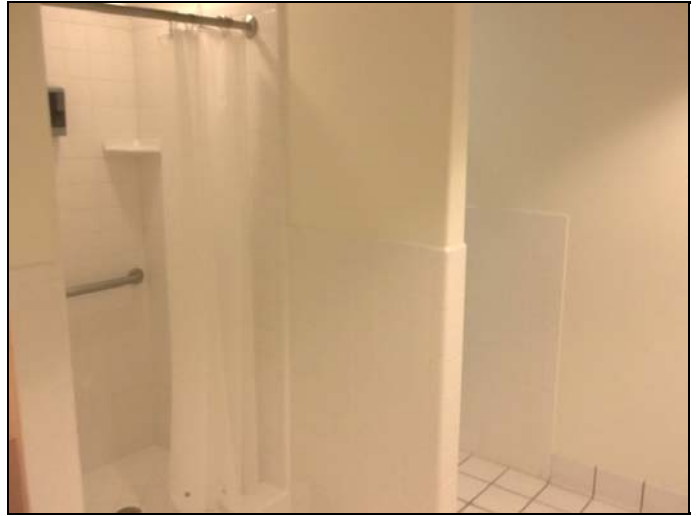
Comp #: 1413 Locker Rooms - Remodel

Research with the client reveals plans to remodel this component in fiscal year 2014. We recommend funding to remodel these restrooms approximately every 18 - 20 years to maintain appearance and keep up with current decorative tastes. Remaining life based on current age.

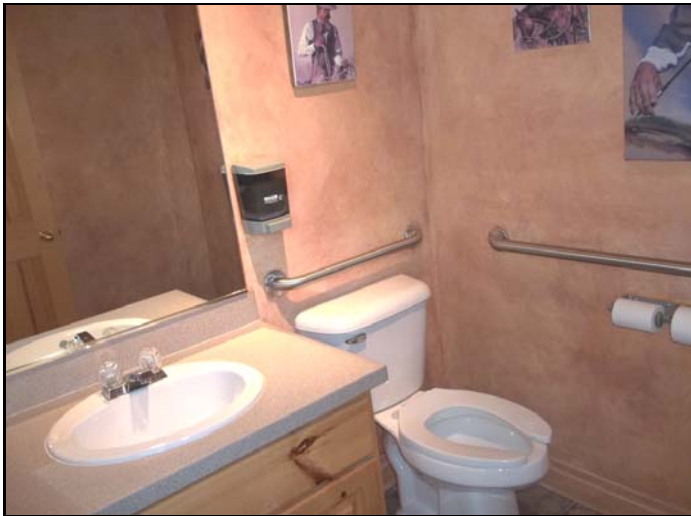
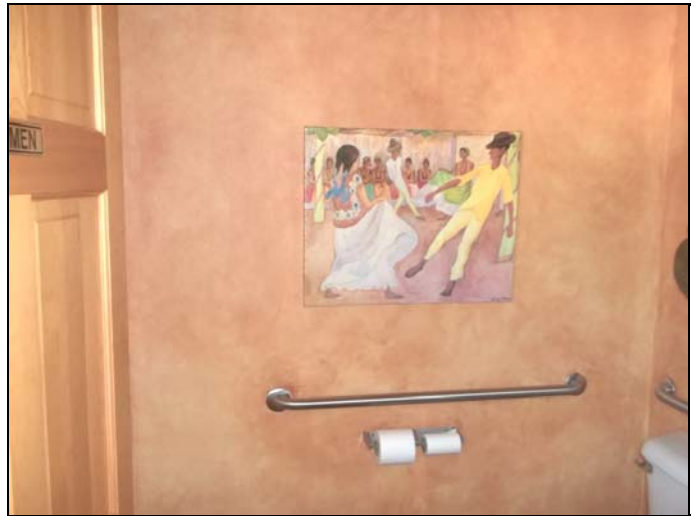
Comp #: 1413 Restroom - Upstairs - Remodel

The restrooms are in good condition. No appearance concerns were noted at the time of the inspection. We recommend funding to remodel these restrooms approximately every 18 years to maintain appearance and keep up with current decorative tastes. Remaining life based on current age and condition.

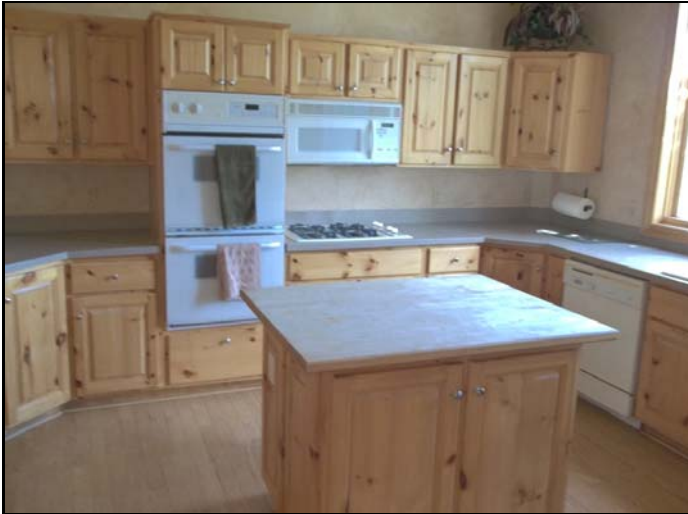
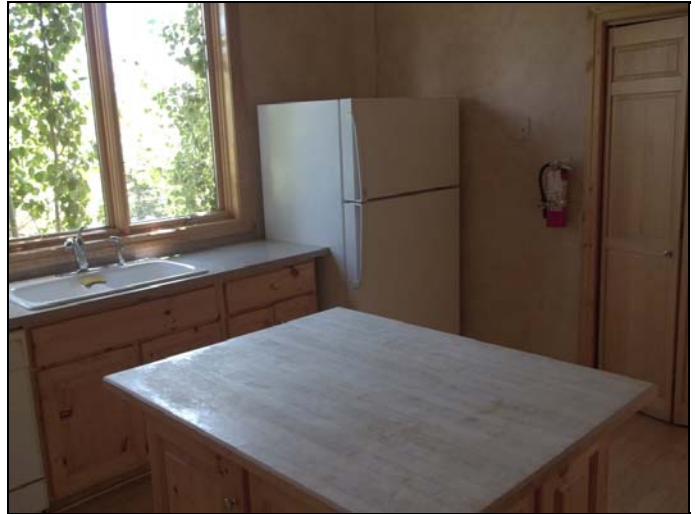
Comp #: 1417 Kitchen - Remodel

The kitchen is in fair to poor condition. The cabinets need to be refinished was noted at the time of the inspection. Expect to remodel kitchen approximately every 20 years to keep up with current decorative tastes and ensure proper function of appliances. Remaining life based on current age.

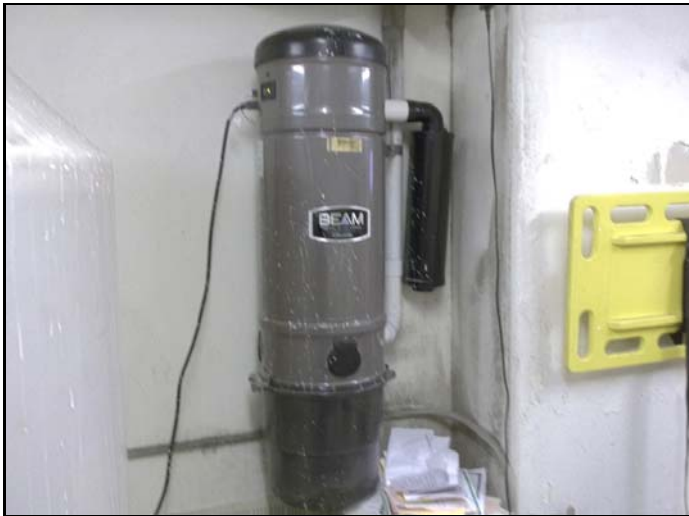
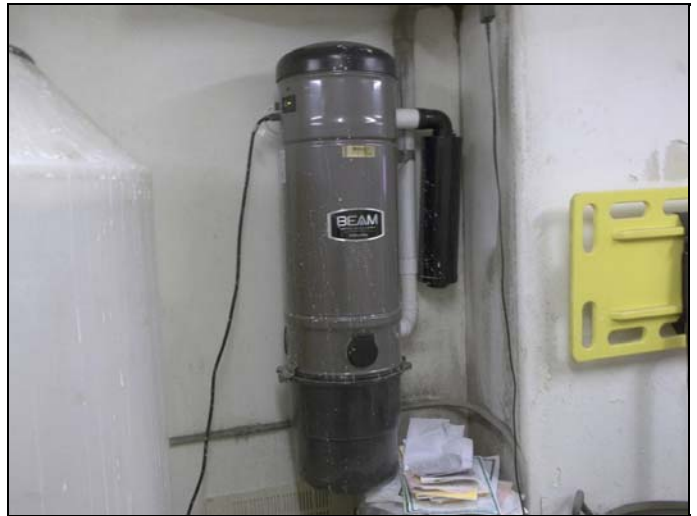
Comp #: 1490 Central Vacuum System - Replace

The central vacuum system is in good condition. No problems were noted or reported at the time of the inspection. We recommend funding to replace this component approximately every 12 - 15 years. Remaining life based on current age.

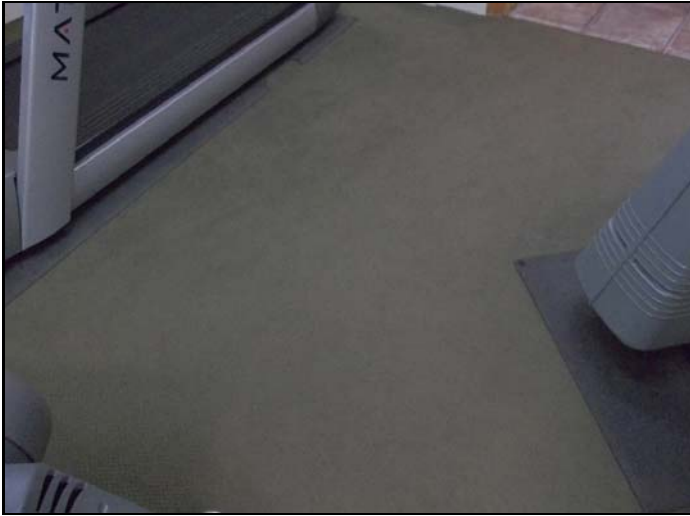
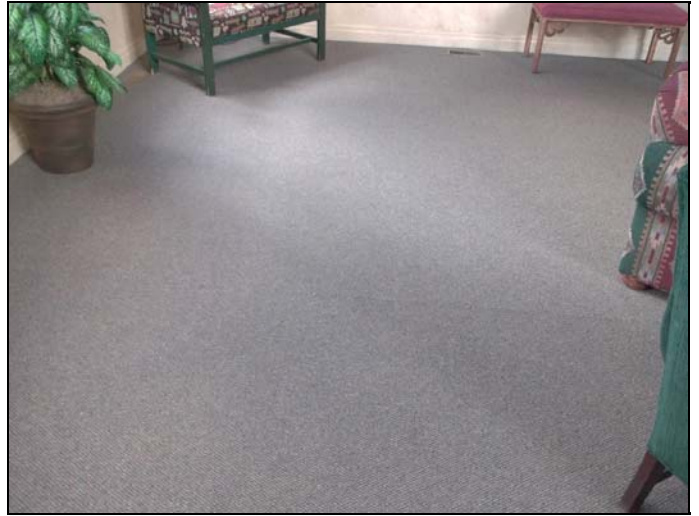
Comp #: 1501 Carpeting - Replace

The carpeting is in fair condition. Snags and stains were noted at the time of the inspection. Expect to replace this component approximately every 6 - 8 years assuming normal use and wear. Remaining life based on current age.

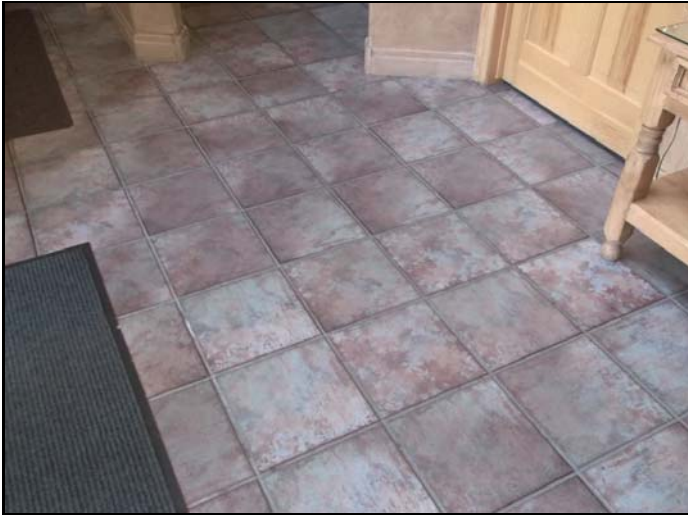
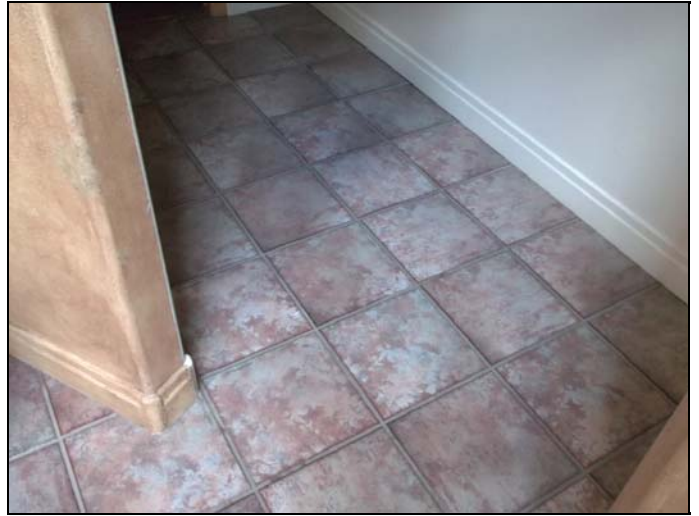
Comp #: 1503 Tile - Replace

The tile is in good condition. No problems were noted at the time of the inspection. Although this component may reach an extended useful life we recommend funding to replace the tile approximately every 30 years to ensure appearance and keep up with current decorative tastes. Remaining life based on current age.

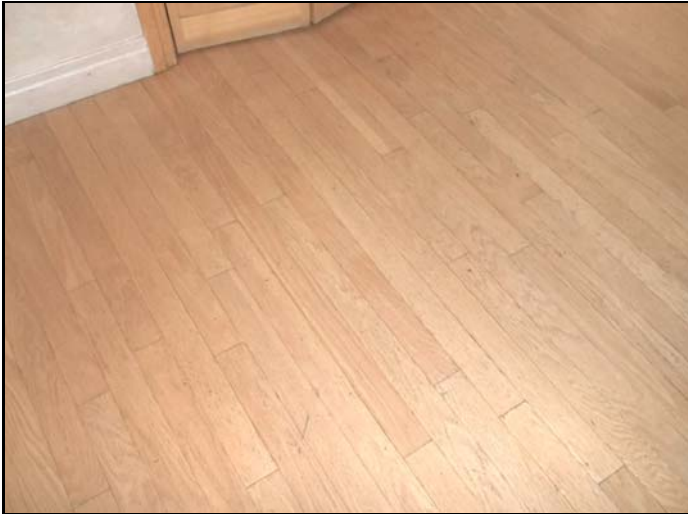
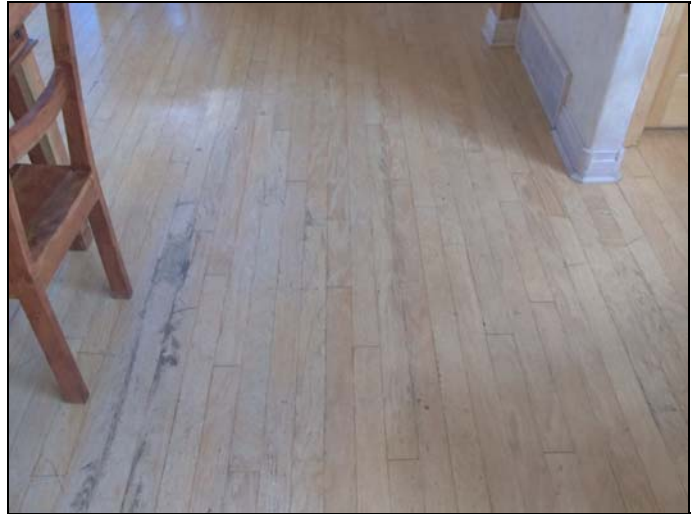
Comp #: 1590 Laminate Flooring - Replace

The laminate flooring surfaces are in fair to poor condition. Research with the client reveals this component has been resurfaced in the past and is in need of replacement. We recommend funding to replace this component approximately every 20 years. Remaining life based on current condition.

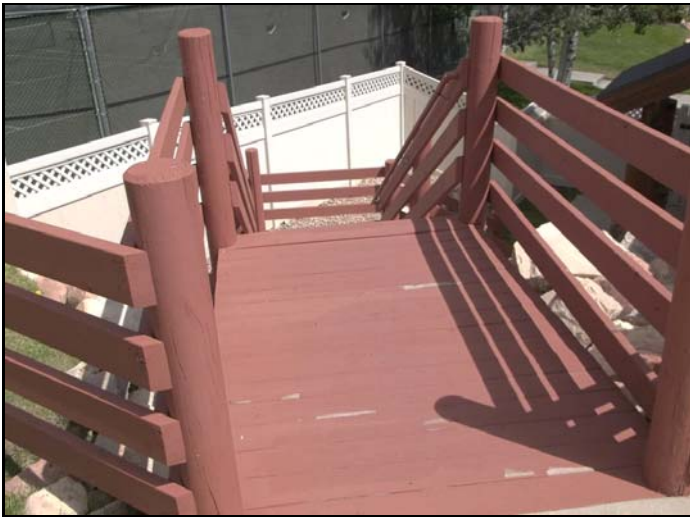
Comp #: 2303 Clubhouse Exterior Stairwells - Replace

The clubhouse exterior stairwells were in good to fair condition. No problem were noted at the time of the inspection. We recommend funding to replace this component approximately every 24 years. Remaining life based on current age.

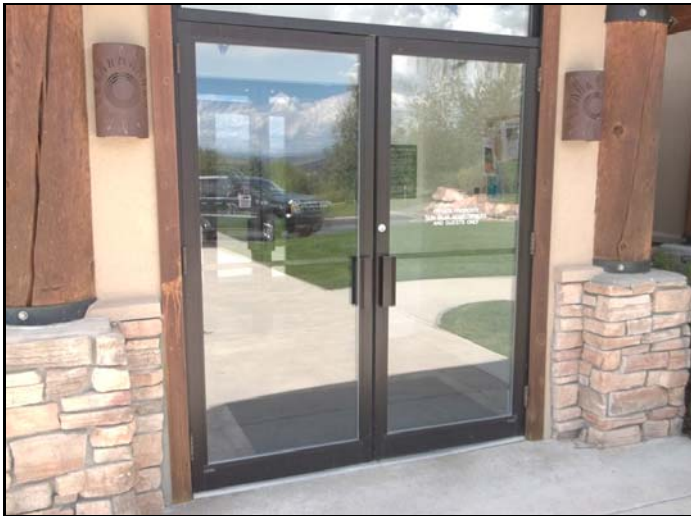
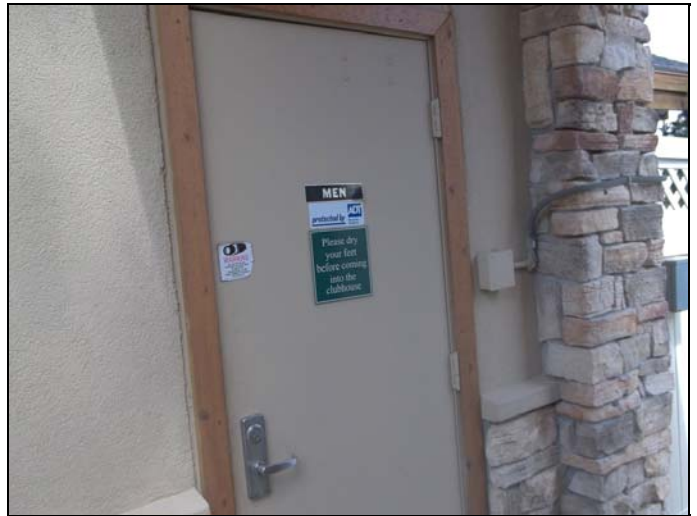
Comp #: 2304 Clubhouse Exterior Doors - Replace

The clubhouse exterior doors are in good condition. Research with the client reveals plans to replace this component approximately every 20 years. Remaining life based on current age.

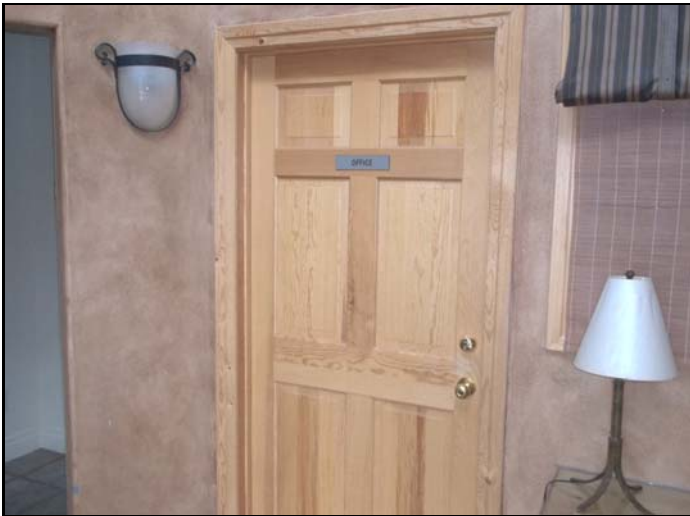
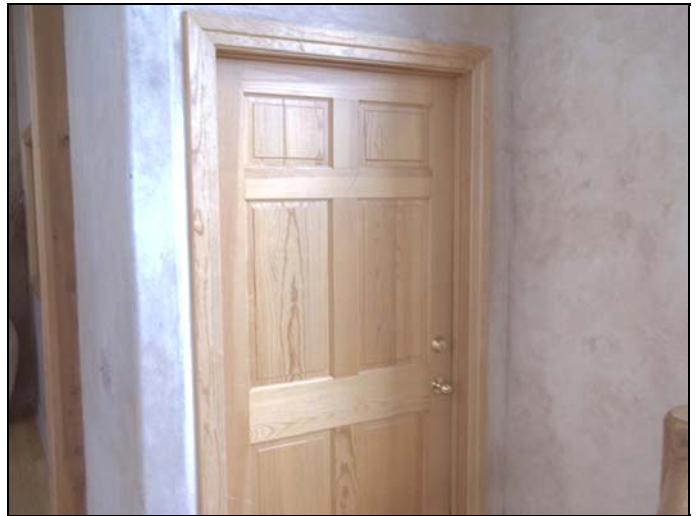
Comp #: 2305 Clubhouse Interior Doors - Replace

The clubhouse interior doors are in good condition. Research with the client reveals plans to replace this component approximately every 20 years. Remaining life based on current age.

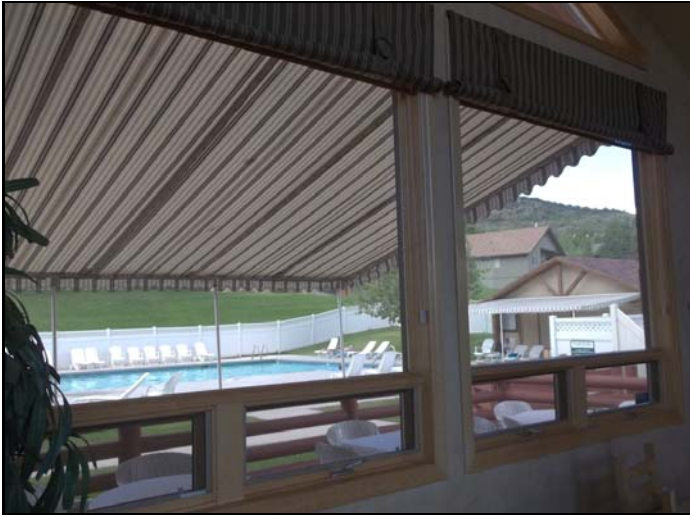
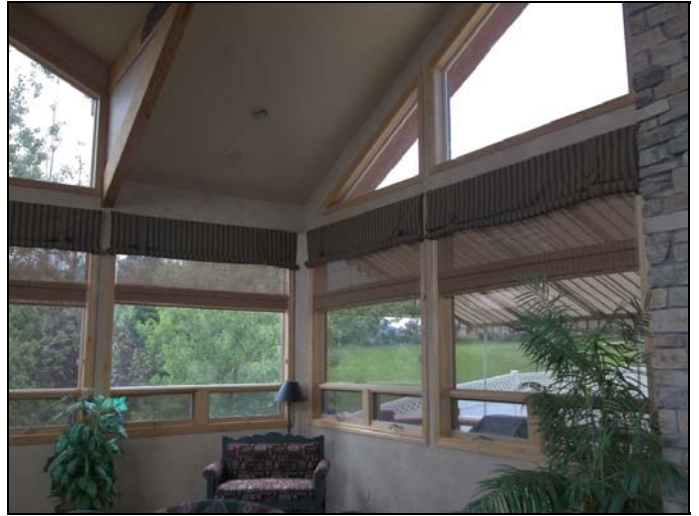
Comp #: 2306 Clubhouse Windows - Replace

The clubhouse windows are in good condition. Research with the client reveals plans to replace this component approximately every 24 years. Remaining life based on current age.
