Report compiled by Bradley Hornsby 2020

All ten manholes in SSSF Underdrain **System Segment B** are **Inactive**, all but 3 are non-accessible; those found openable are dry. No benefits to the Homeowners. See Report on **Segment A** the five functional MHs.

SILVER SPRING PHASE 1A & 1B UNDERDRAIN SYSTEM

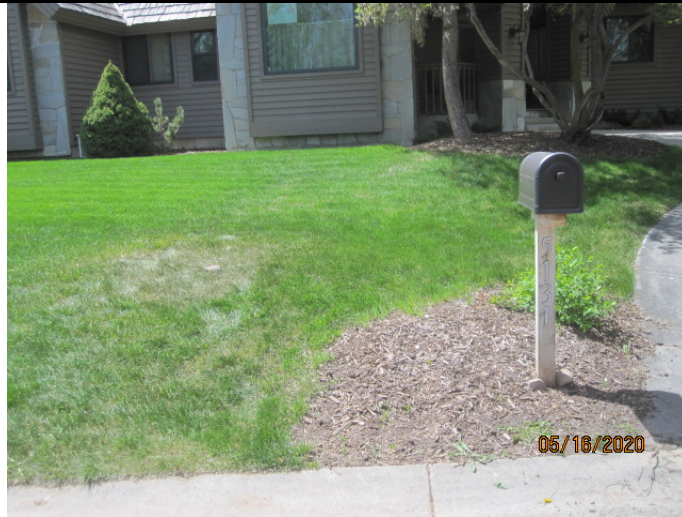
Continuation from above of **mh 6B**.

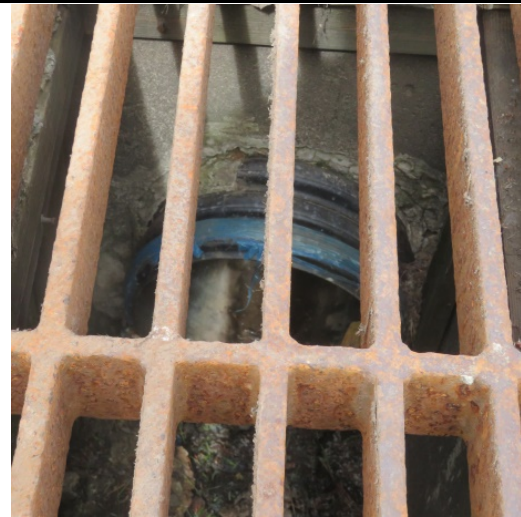
Storm Drain grate SW corner 23.5 feet.

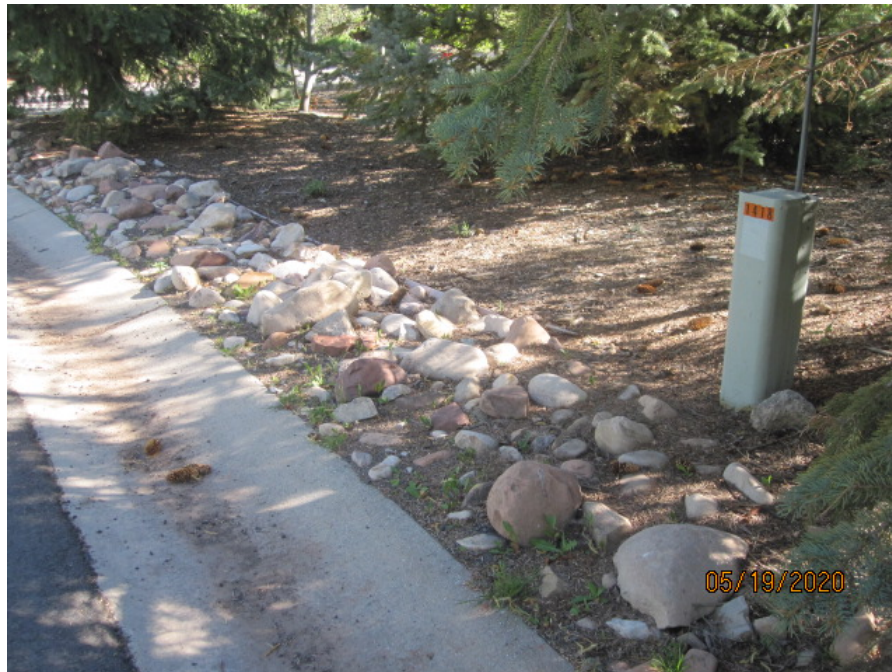
mh 7B Lots 132 (1414) & 133 (1418) Silvero. Alliance Engineering never found this mh. Investigation into Willow Lane indicates this line and mh were either not installed, or collapsed. Willow Creek divides Ranch Place undeveloped wet lands (currently suffering from eight successive years of drought) from Silver Springs Single Family homes along Willow Lane. **Inactive**. DNF.

The "as built" plats from J.J Engineering show that **mh 7B** is at the center line of the twin lots 132 & 133, nearly at the curb gutter. That UD line continues south from East Meadows, curving north. There is a catch basin in the road at the intersection of Willow Lane and Ranch Place (road). When we opened the steel lid we found it completely dry without a single inlet or outlet; cement collar installed in 2019.

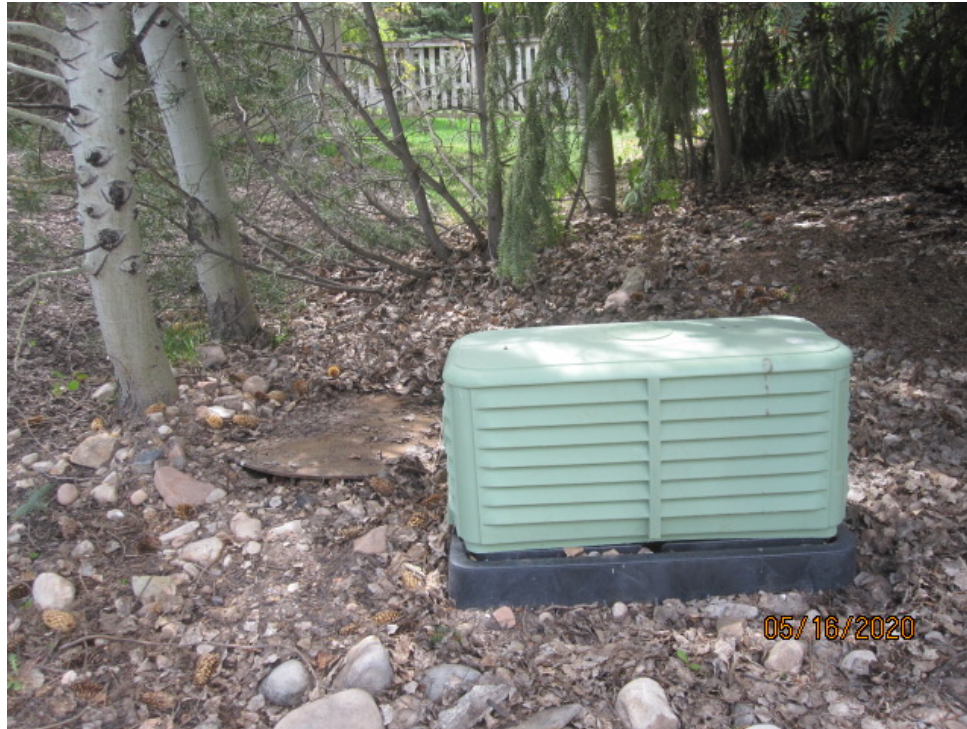
mh 8B Lot 111 Klusman on East Meadows Drive. **Dry conduit.** Alliance Engineering: “Steel lid exposed at grade between Lot 111 & 112” behind green electric box. “Sewer Mh 19.8 feet. Teleped 21 ft., 5.6 feet behind gutter.”

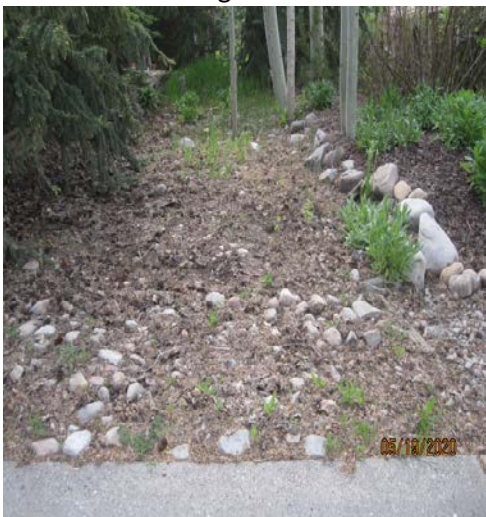
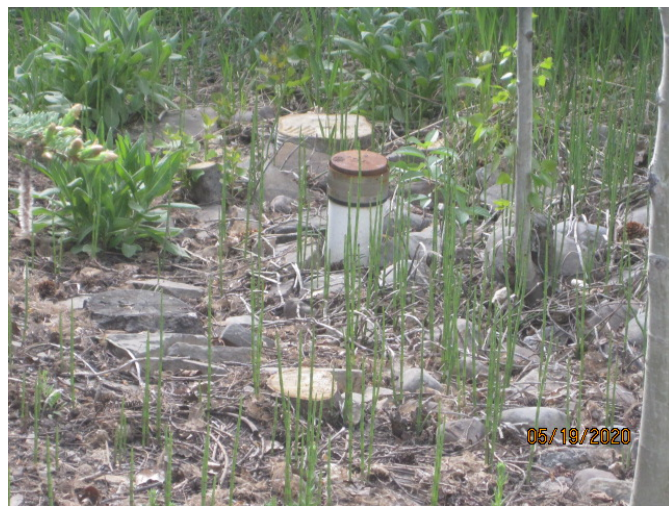
mh 9B East Meadows Drive Lots 84 Callahan & 108 Palomaki (these are adjoining lots). Alliance Engineering: “Did not find manhole.” Location based on underdrain map “as built” plat. On the “as built” diagram manhole 9A is centered on the property line of the two lots, near the curb.

Figure 1. Neither Alliance Engineering nor did we find UD mh 9B. **Inactive.** Not accessed.

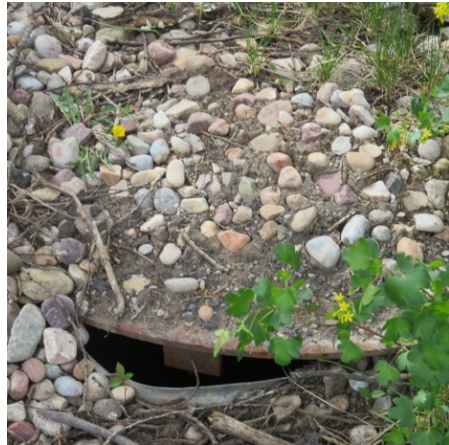
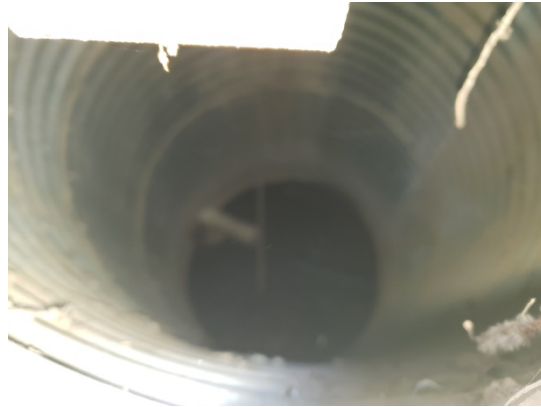
mh 10B Lot 145 Marchetti on Fletcher Ct. – This steel lid was found at grade exposed near the curb and photographed. Interior of conduit was quite DRY. Alliance Engineering: “1.9 feet behind curb. 45.5 feet from Lot 45 mailbox, and 36.1 feet from Lot 146.” Completely dry. **Inactive.**

Exterior uncovered lip of drain and cover. Interior photo taken with camera probe. Found to be Dry.

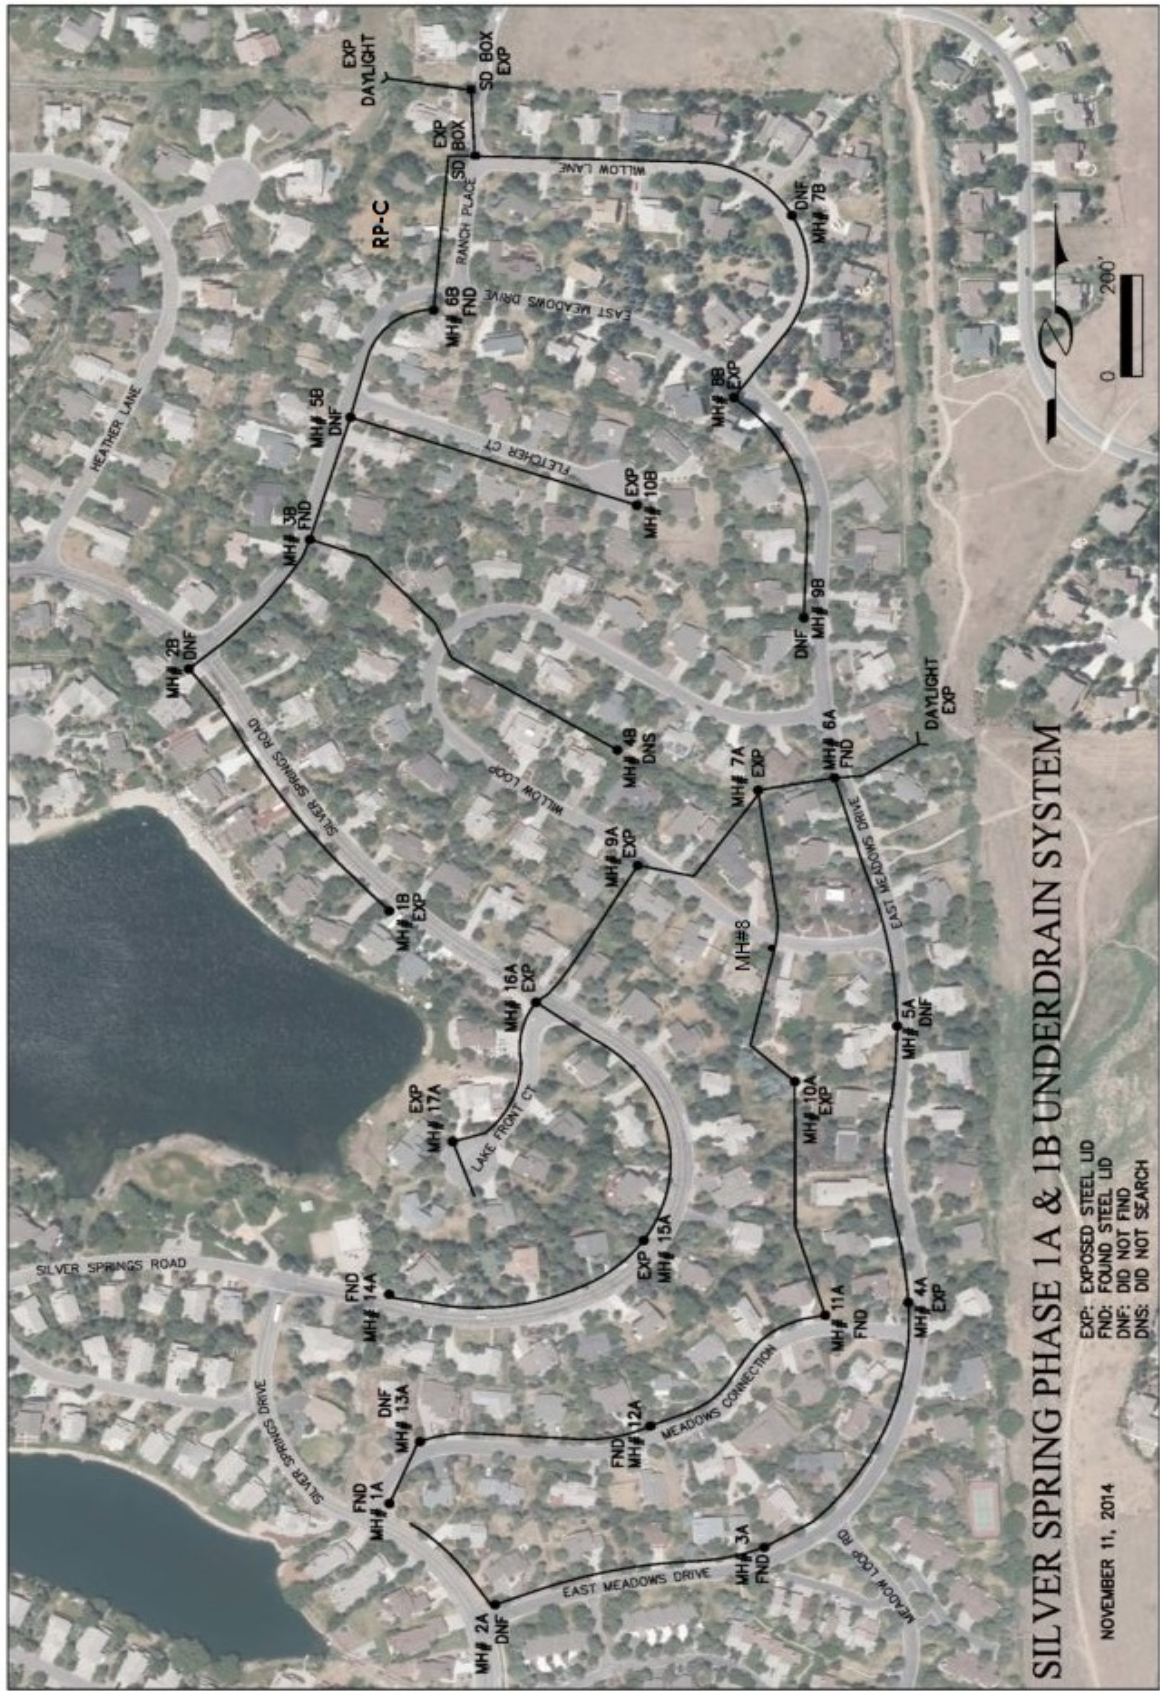
EXP: EXPOSED STEEL LID
 FND: FOUND STEEL LID
 DNF: DID NOT FIND
 DNS: DID NOT SEARCH
